AN
INSPECTION REPORT
OF
WEATHER AND RAD-SAFE STATIONS

30 July Thru 3 August 1959

WEATHER STATION - PONAPE

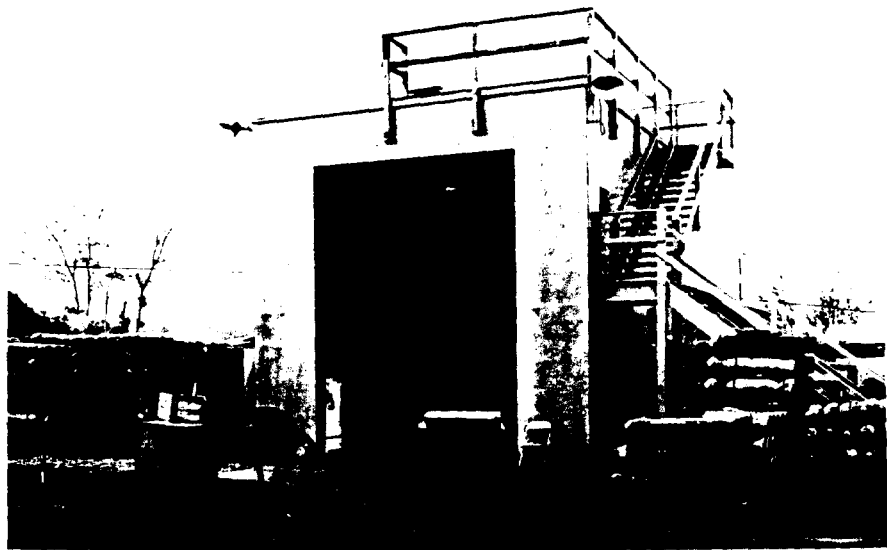
1. The weather station building, which is being operated by the U.S. Weather Bureau, appears to be in very good condition structurally. A small amount of dry rot occurs at the base of the stair posts and Mr. Hirada intends to have the posts incased in concrete approximately 12" above the footings. During windy rainstorms, a small portion of the roof develops slight leaks. This he proposes to repair with mastic and metal flashing. Mr. Hirata further proposes to build a small shelter to house an emergency generator. This will keep the station operable during power failures at the main plant.

CLASSIFICATION	000	<input checked="" type="checkbox"/> INFORMATION
PHOTOGRAPHER	COE	<input type="checkbox"/> PICTORIAL
		<input type="checkbox"/> PROGRESS _____ %
<u>13-35-12-12</u>	<u>7-30-99</u>	<u>Ponape</u>
NEGATIVE NO.	DATE	SITE
WEATHER STATION

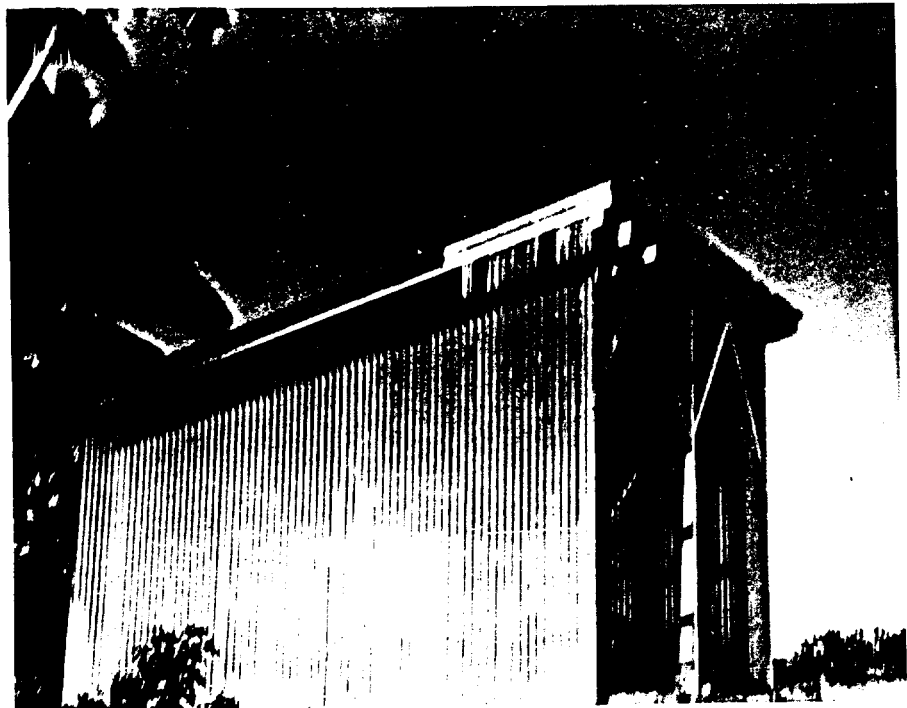
1. PUMP HOUSE - Slight weather damage to roof, one section of aluminum sheathing missing and one aluminum window shutter is hanging by one hinge. Otherwise in good condition.

CLASSIFICATION	CUO	<input checked="" type="checkbox"/> INFORMATION
PHOTOGRAPHER	COE	<input type="checkbox"/> PICTORIAL
13-35-12-15	8-1-59	<input type="checkbox"/> PROGRESS _____ %
NEGATIVE NO.	DATE	SITE
Kapingamarangi		
VIEW OF ROOF SECTION POSING FROM THE CORNER ROOF

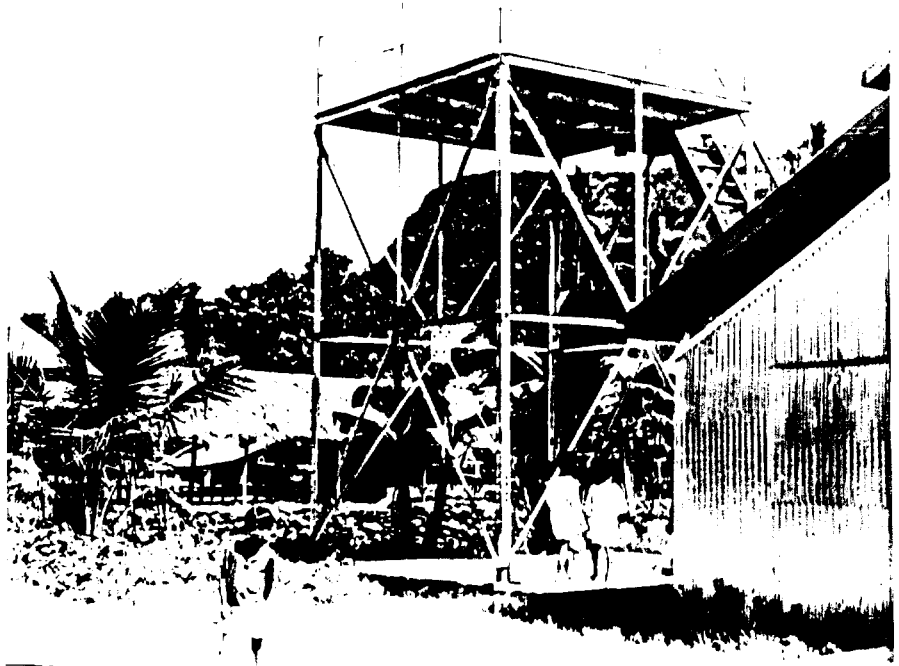
1. SUPPLY & OPERATIONS - In good condition.
2. GENERATOR SHED - In good condition.
3. RAWINSONDE TOWER - In good condition. However the vertical steel poles and steel angles are beginning to show signs of rust.
4. PIT LATRINE - Apparently good condition, but should be replaced.
5. FUEL TANK BASE - In good condition.
6. REEFER SHED - In good condition.

CLASSIFICATION	000	<input checked="" type="checkbox"/> INFORMATION
PHOTOGRAPHER	COE	<input type="checkbox"/> PICTORIAL
		<input type="checkbox"/> PROGRESS _____ %
<u>13-35-13-3</u>	<u>8-2-59</u>	<u>KUSAIB</u>
NEGATIVE NO.	DATE	SITE
RANIRSONDE TOWER		SITE "A"

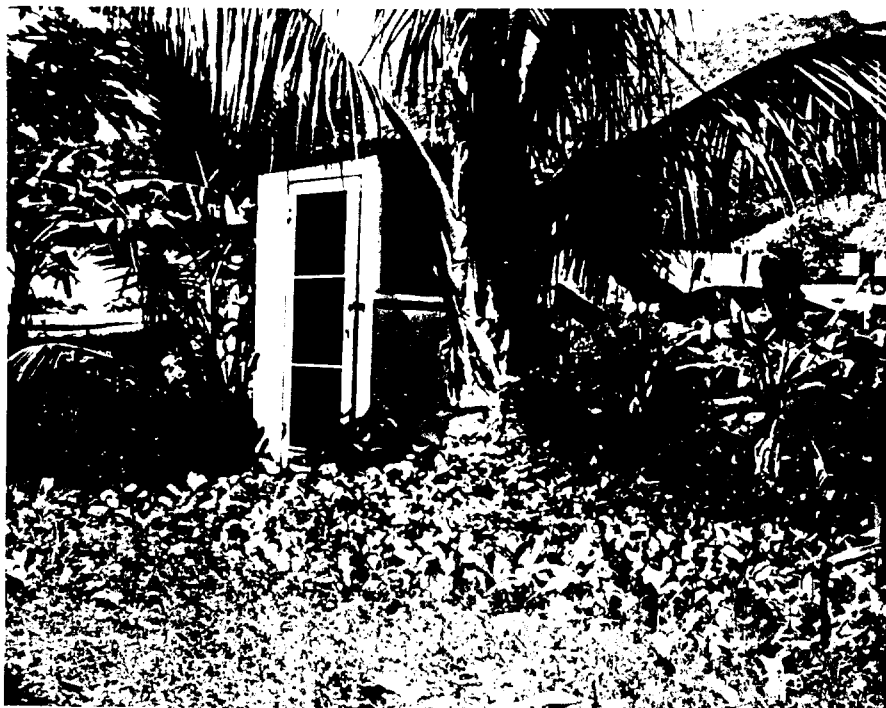
CLASSIFICATION	OUO	<input checked="" type="checkbox"/> INFORMATION
PHOTOGRAPHER	COB	<input type="checkbox"/> PICTORIAL
		<input type="checkbox"/> PROGRESS _____ %
<u>13-35-13-6</u>	<u>8-2-59</u>	<u>Rusaie</u>
NEGATIVE NO.	DATE	SITE
PIT LATRINE		SITE "A"

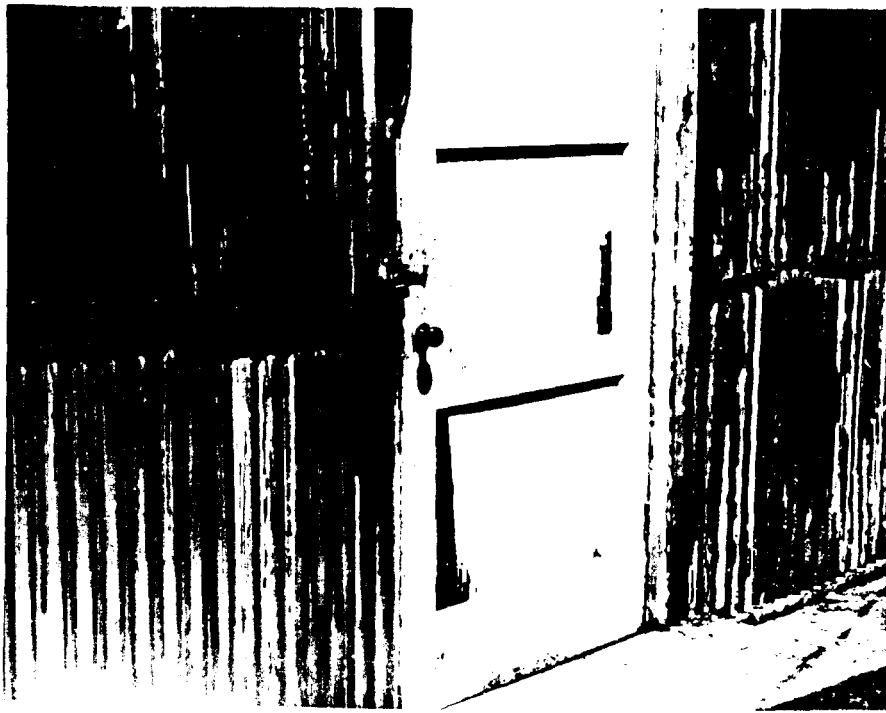
1. REEFER SHED - In good condition.
2. MESS HALL - Two of the doors are beyond repair due to dry rot and need to be replaced. A screen is missing from one window. Otherwise the building is in good condition.
3. DAY ROOM - Is in good condition.
4. BARRACKS - Is in good condition.
5. BARRACKS - Is in good condition.
6. POWER HOUSE - Is in good condition.
7. DISTILLATION SHED - Is in good condition.
8. WATER TOWER - There is evidence of dry rot in the bottom 6 inches of each of the tower legs. Also, several planking are missing from the platform. Repairs could be easily made to place the tower in good working condition.
9. BARRACKS - In good condition, except for one door which is beyond repair with dry rot and needs to be replaced.
10. ANTENNA POLES - In good condition.
11. SEWER OUTFALL - Has disappeared and needs to be replaced.

CLASSIFICATION	000	<input checked="" type="checkbox"/>	INFORMATION
PHOTOGRAPHER	CCS	<input type="checkbox"/>	PICTORIAL
		<input type="checkbox"/>	PROGRESS _____ %
<u>13-35-13-15</u>	<u>8-2-59</u>	<u>Russia</u>	
NEGATIVE NO.	DATE	SITE	
VIEW OF DOOR SW END MESSHALL SITE "B"

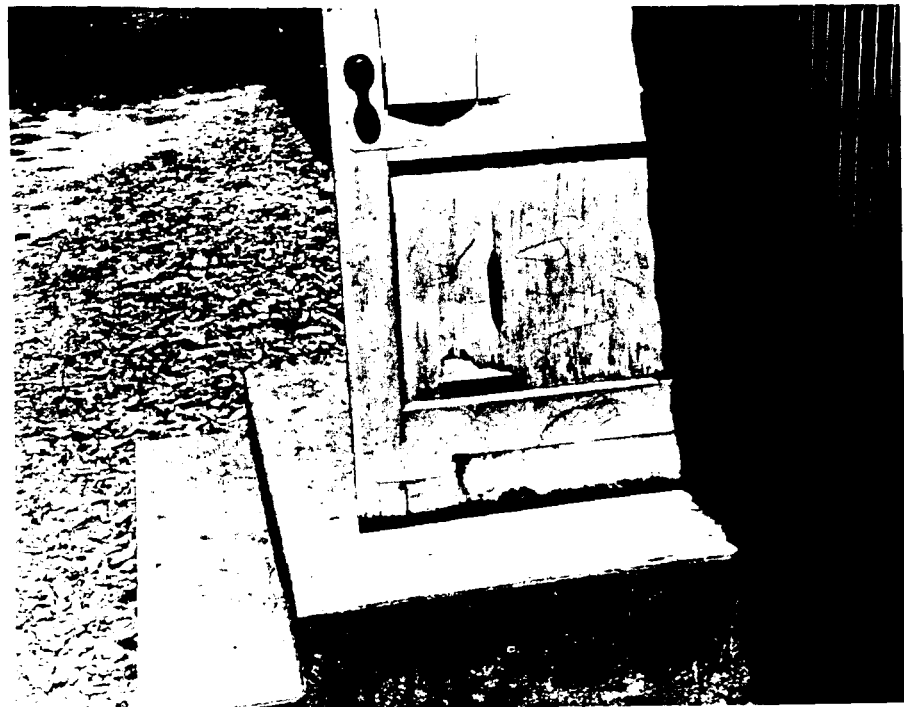
CLASSIFICATION	000	<input checked="" type="checkbox"/>	INFORMATION
PHOTOGRAPHER	CCS	<input type="checkbox"/>	PICTORIAL
		<input type="checkbox"/>	PROGRESS _____ %
<u>13-35-13-16</u>	<u>8-2-59</u>	<u>Russia</u>	
NEGATIVE NO.	DATE	SITE	
VIEW OF DOOR SW SIDE MESSHALL SITE "B"
