COMPLETION REPORT

ENIWETOK PROVING GROUND FACILITIES

VOL. III CONSTRUCTION

HOLMES & NARVER, INC.
LOS ANGELES, CALIFORNIA

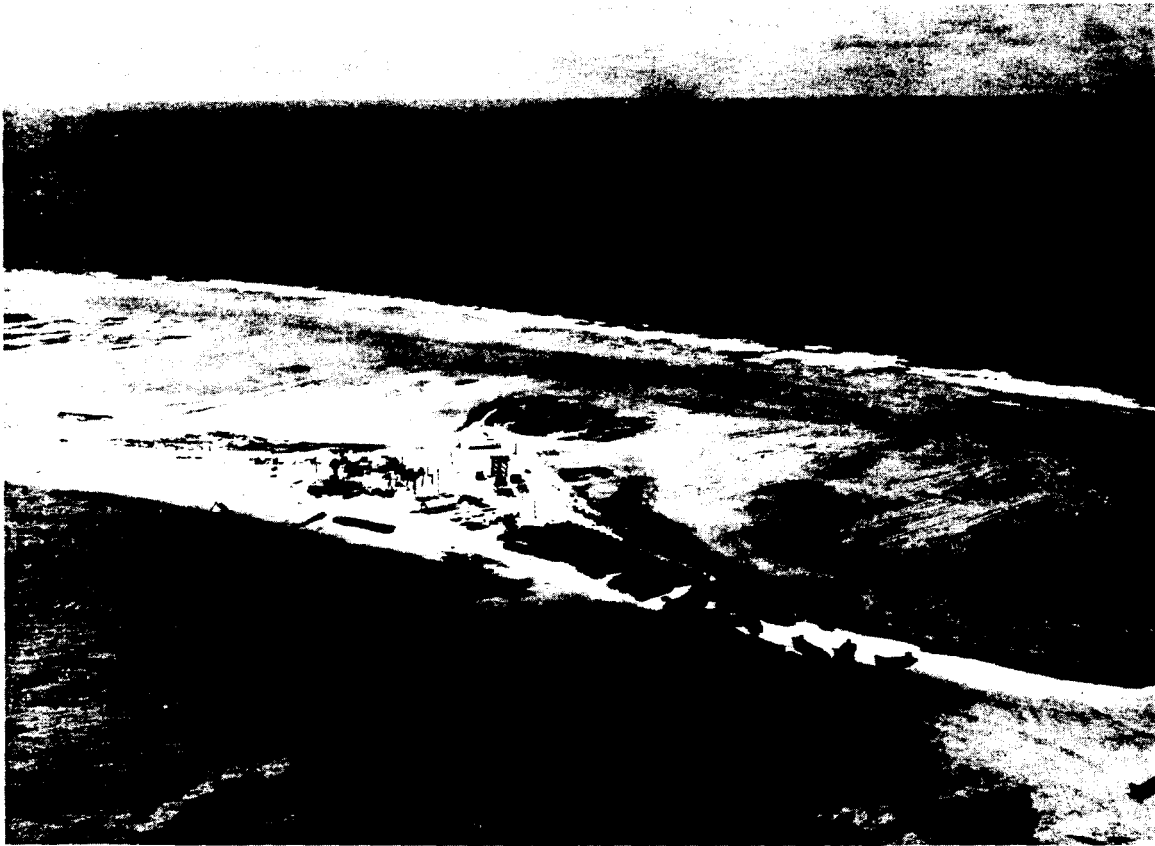
Semi-Permanent Campsite on South End of Runit, Showing Camp Under Construction. Beached LCM'S from World War II Were Later Removed to Clear Area for Scientific Stations.

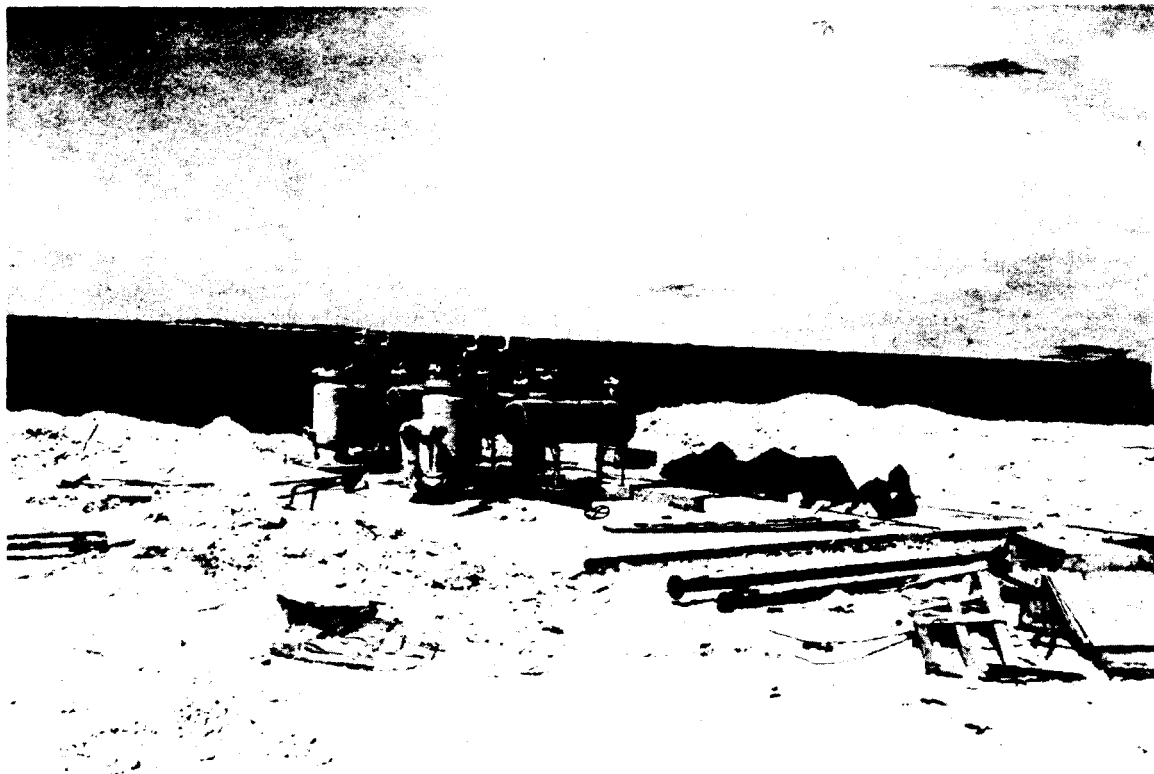
Air Eliminators & Oil Dehydrators Being Installed in Slab for
the POL Pumphouse, Parry Island.

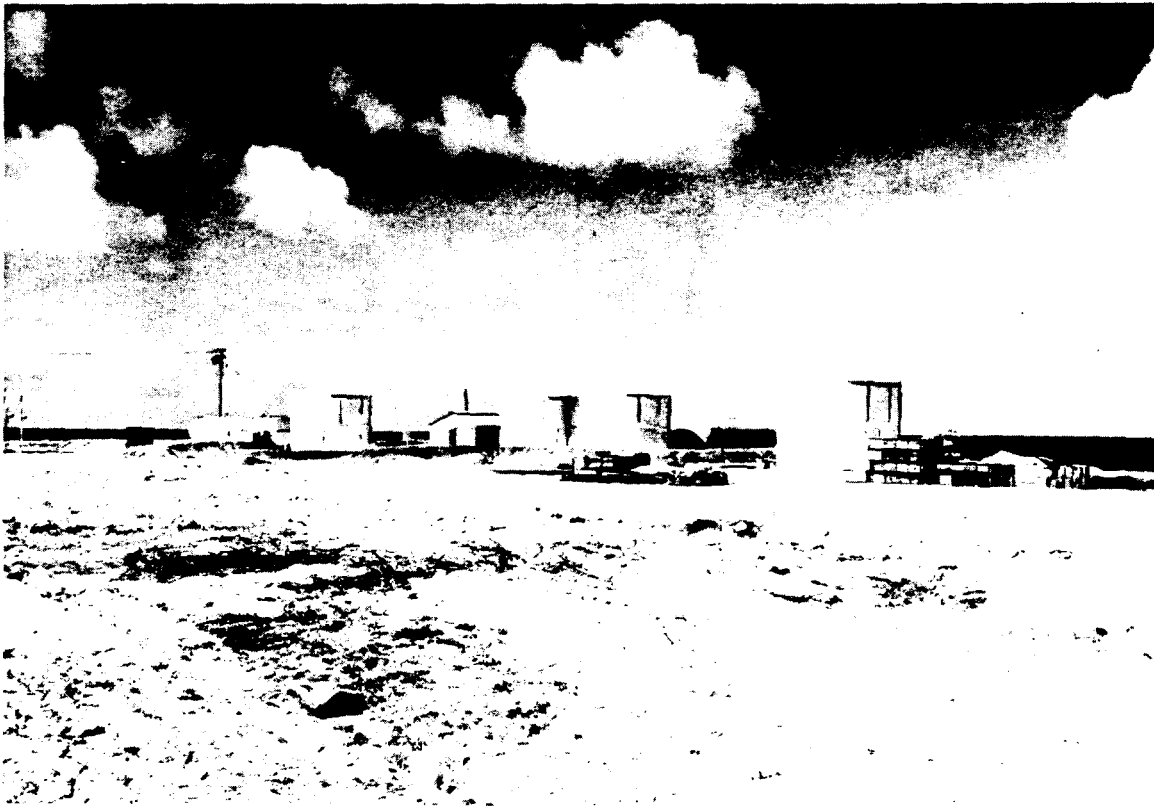
POL Tank Farm, Parry Island, Showing Part of Tanks Installed,
Pump House in Background.

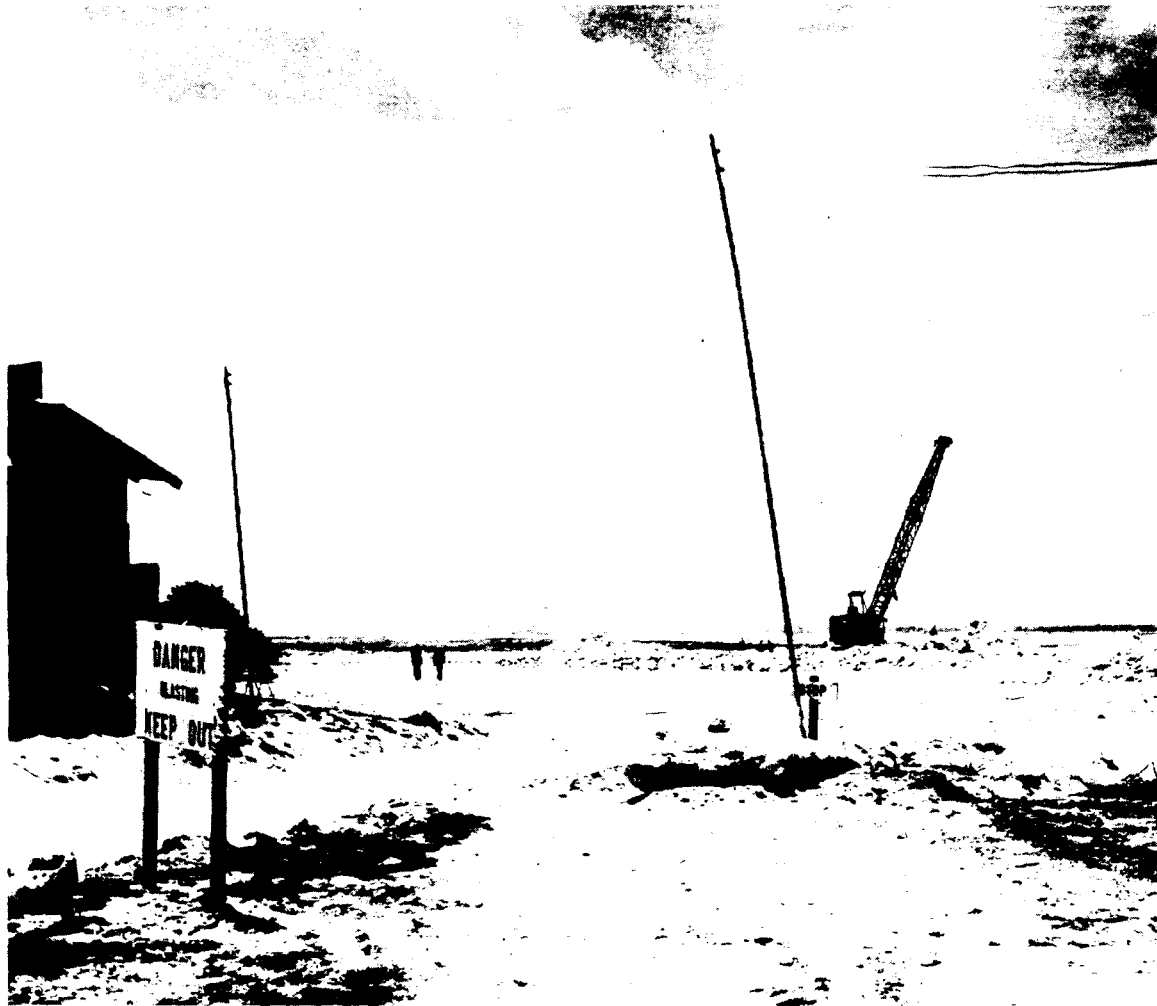
Blasting Coral Ledge on Reef to Obtain Rock for Crusher Plant.

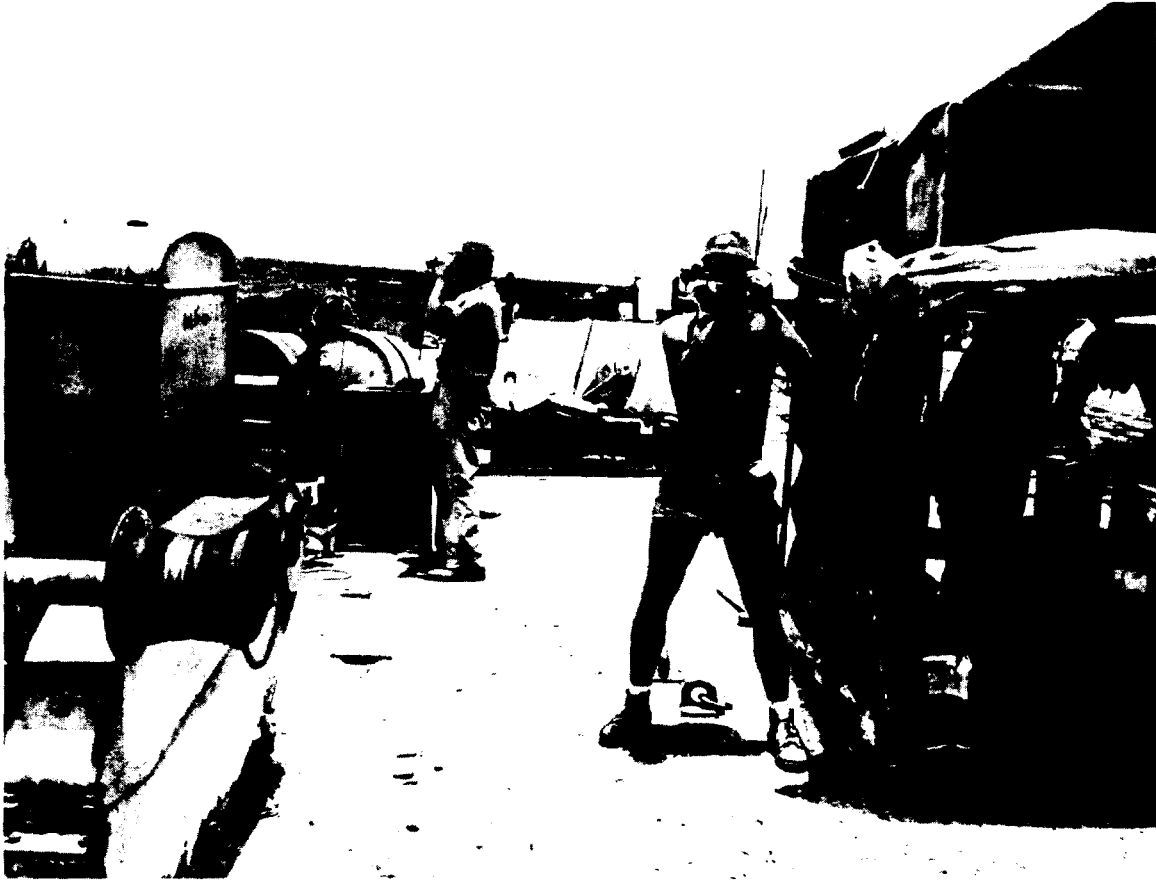
Engineers on Cable Laying Barge Sighting Check Points on Shore.

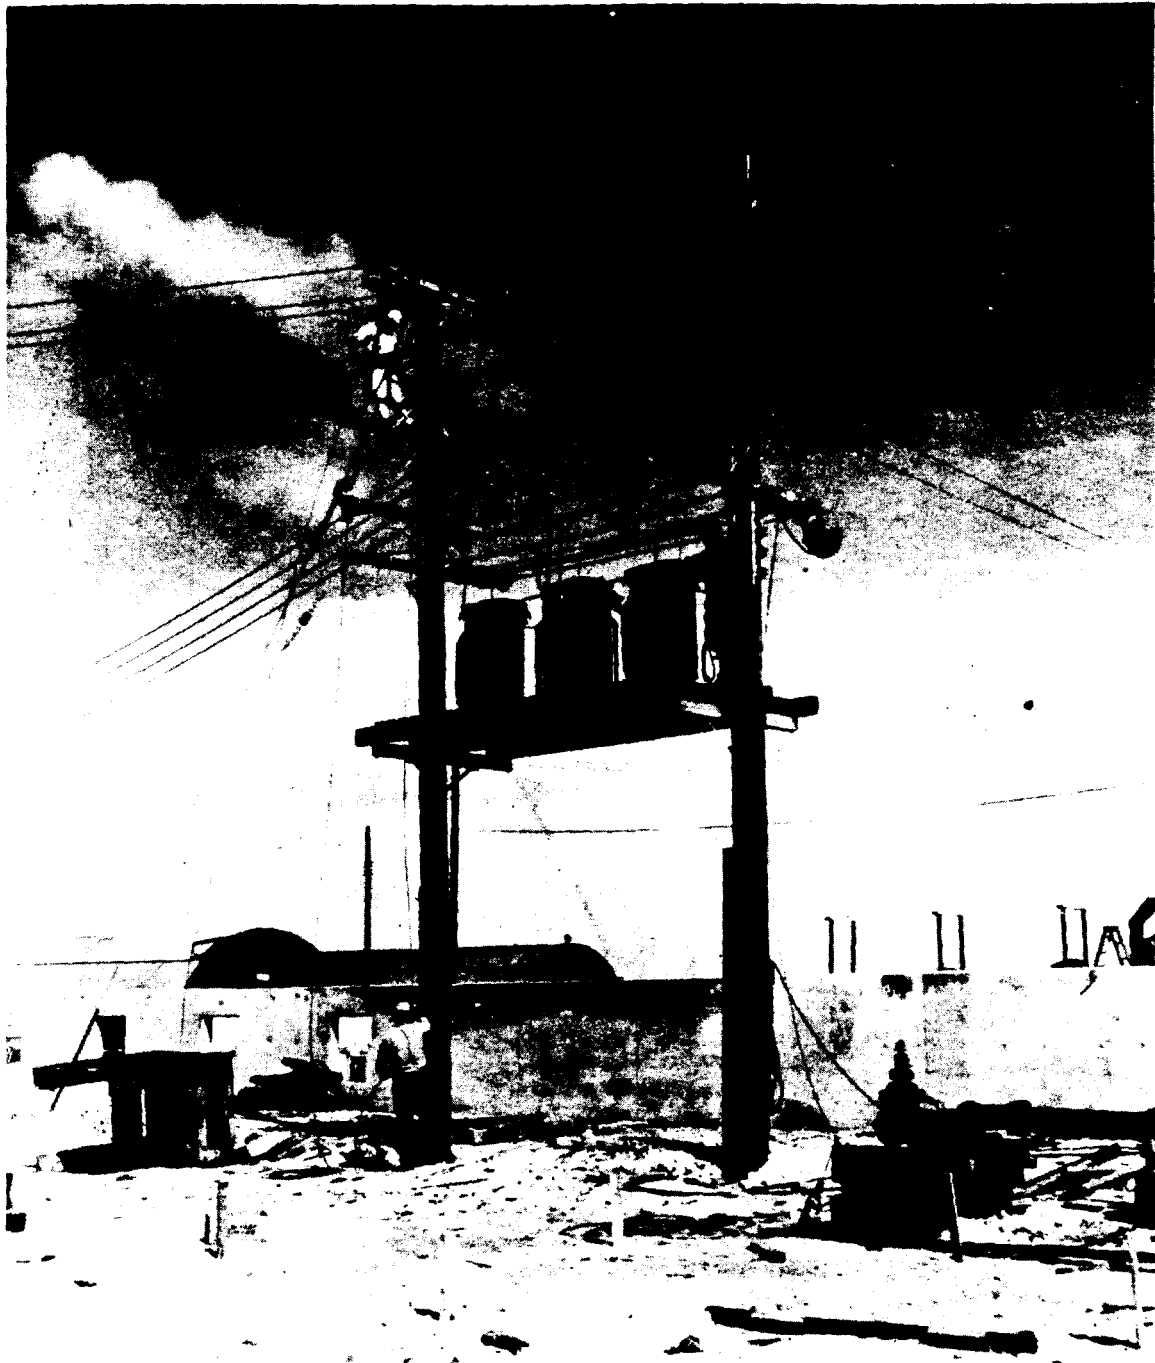
Connecting Transformer Bank for Overhead Power Distribution
System, Parry Island.

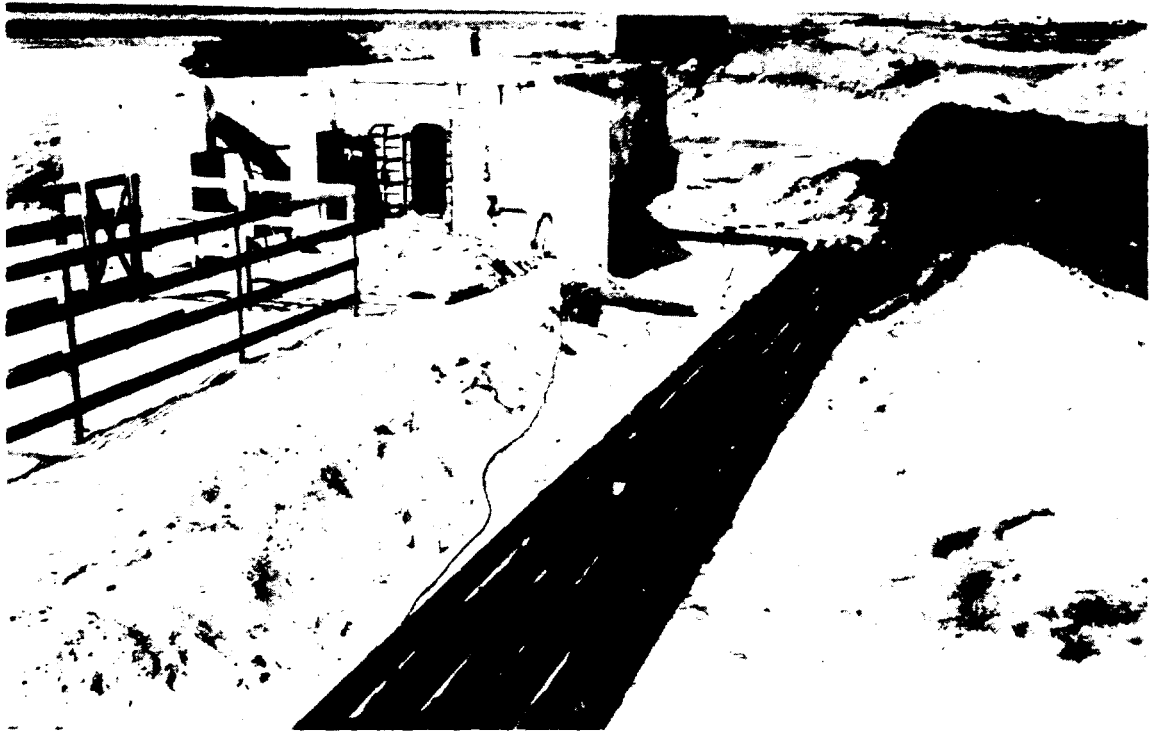
Six-Inch Conduit Installation Between Scientific Station 69 &
6b, Biijiri

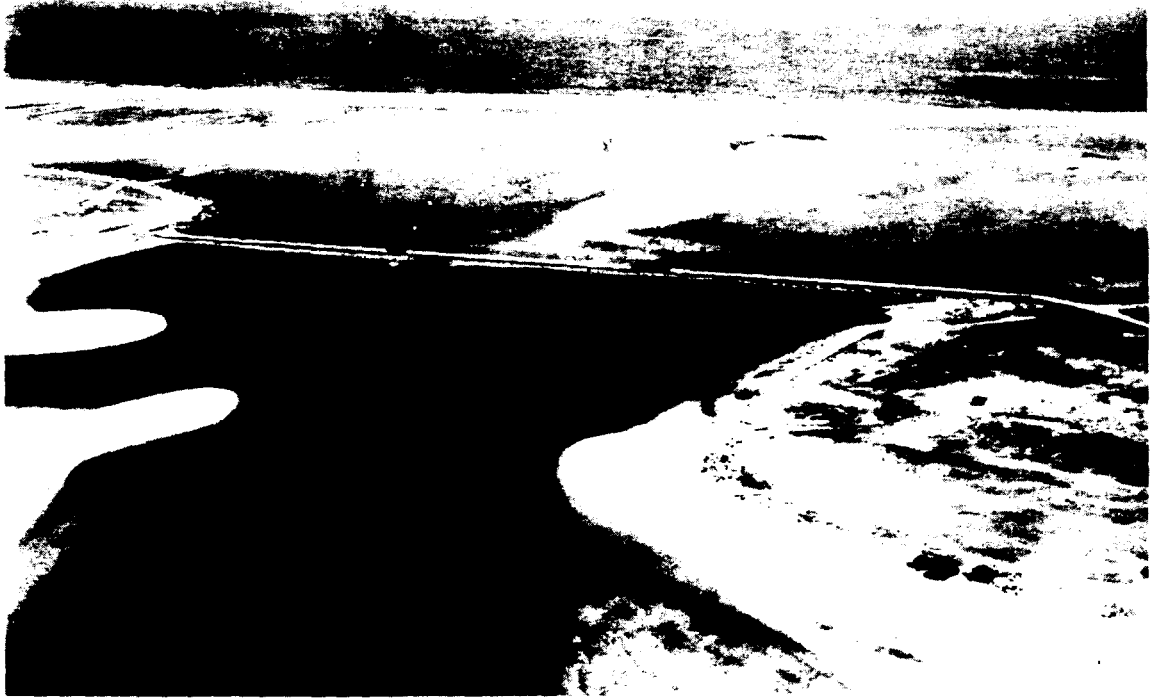
Coral and Sand Fill Causeway Housing Coaxial Cable Trench
Between Ebiriru and Aomon.

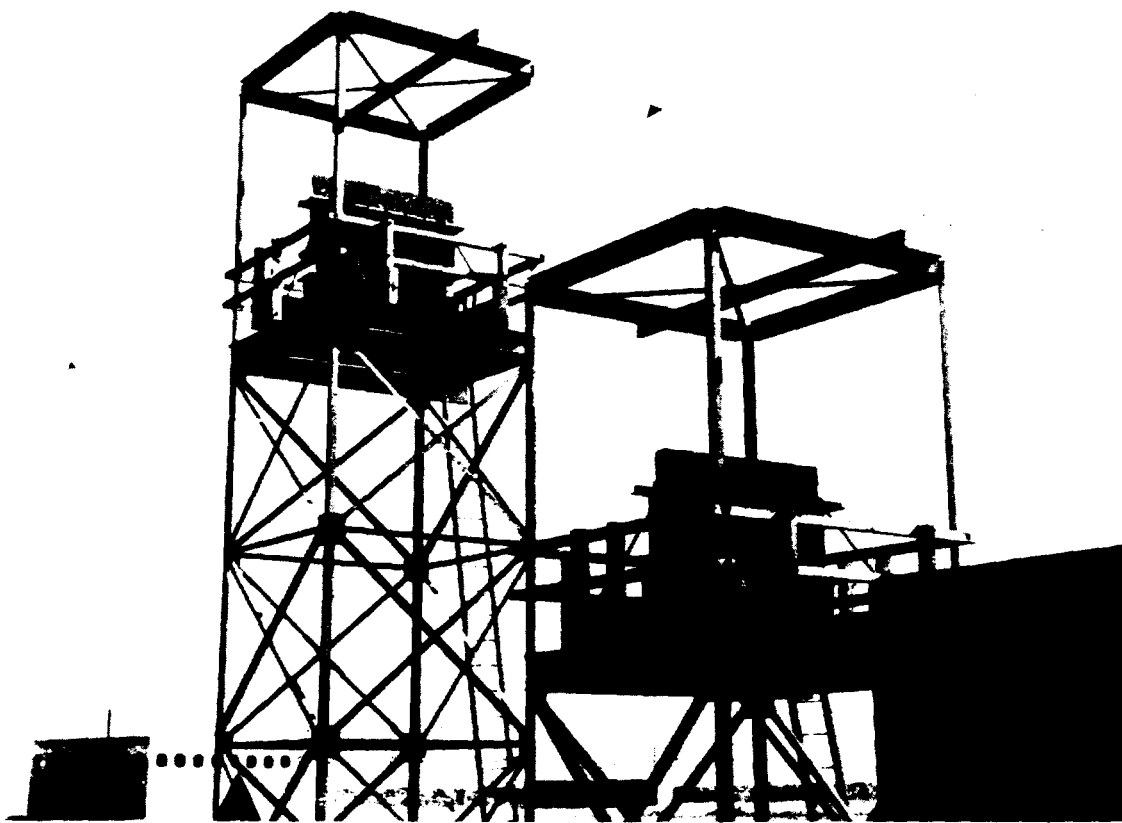
Ganex Towers, Station Nos. 145 & 146, Erected in Front of
Station No. 144a.

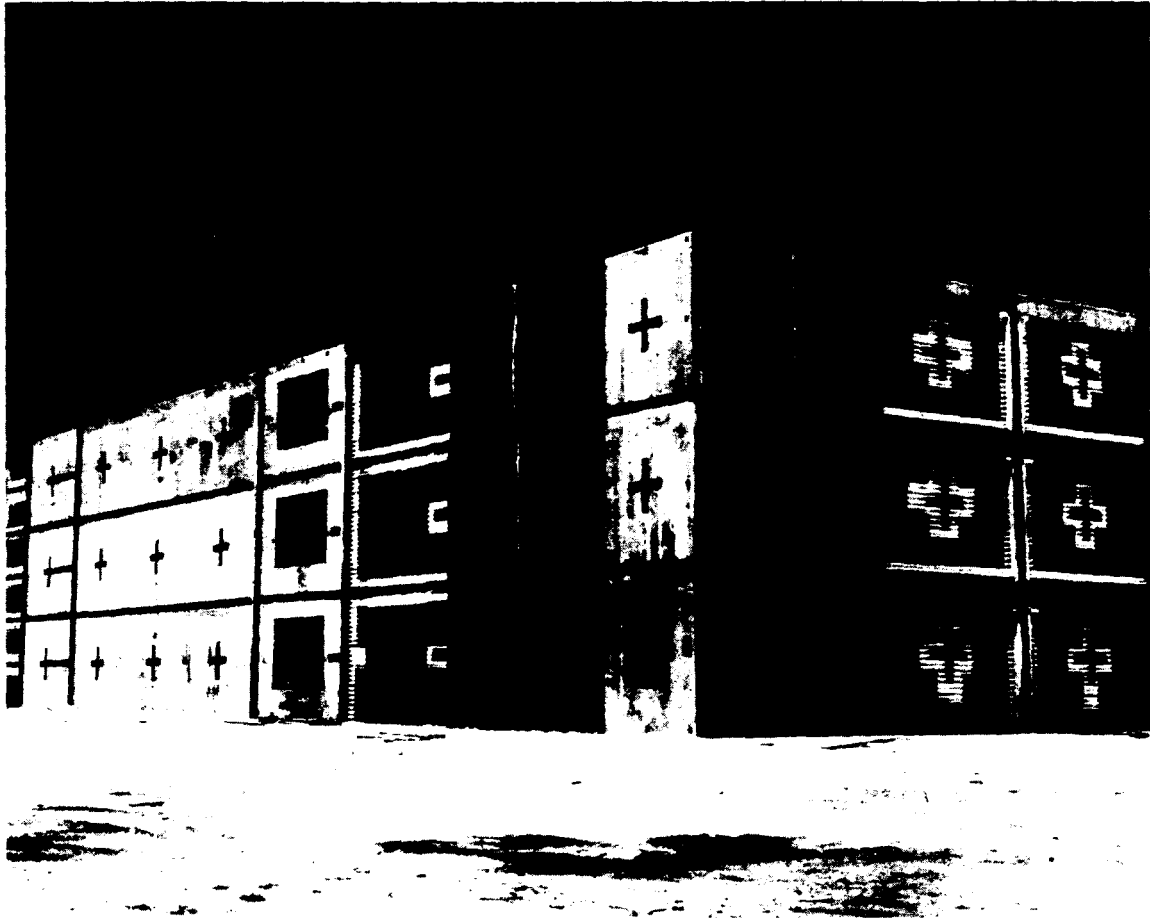
Engebi: Military Structures Program, Station 3.1.1 (Army),
Front View of Completed Building.

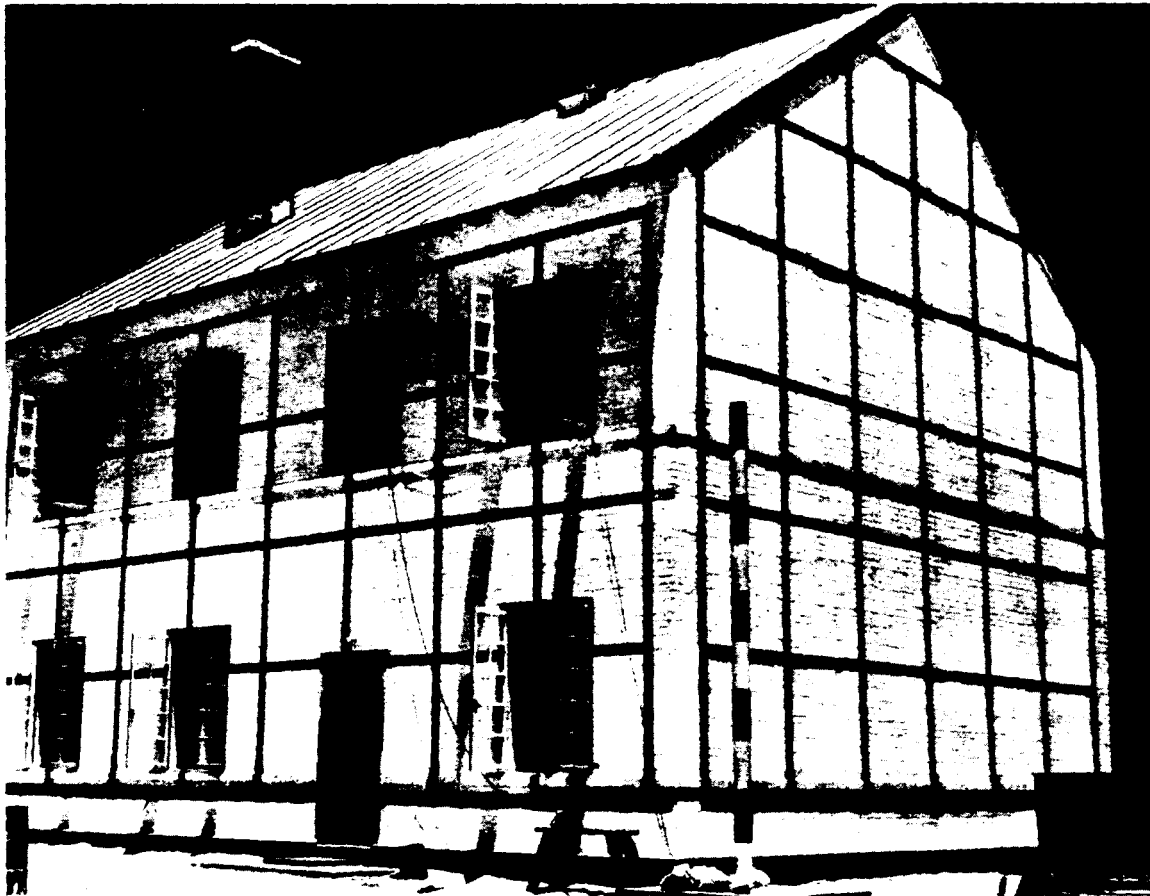
Front Elevation of Brick House, Military Structures Program,
Station 3.3.5a (Air Force) on Engebi.

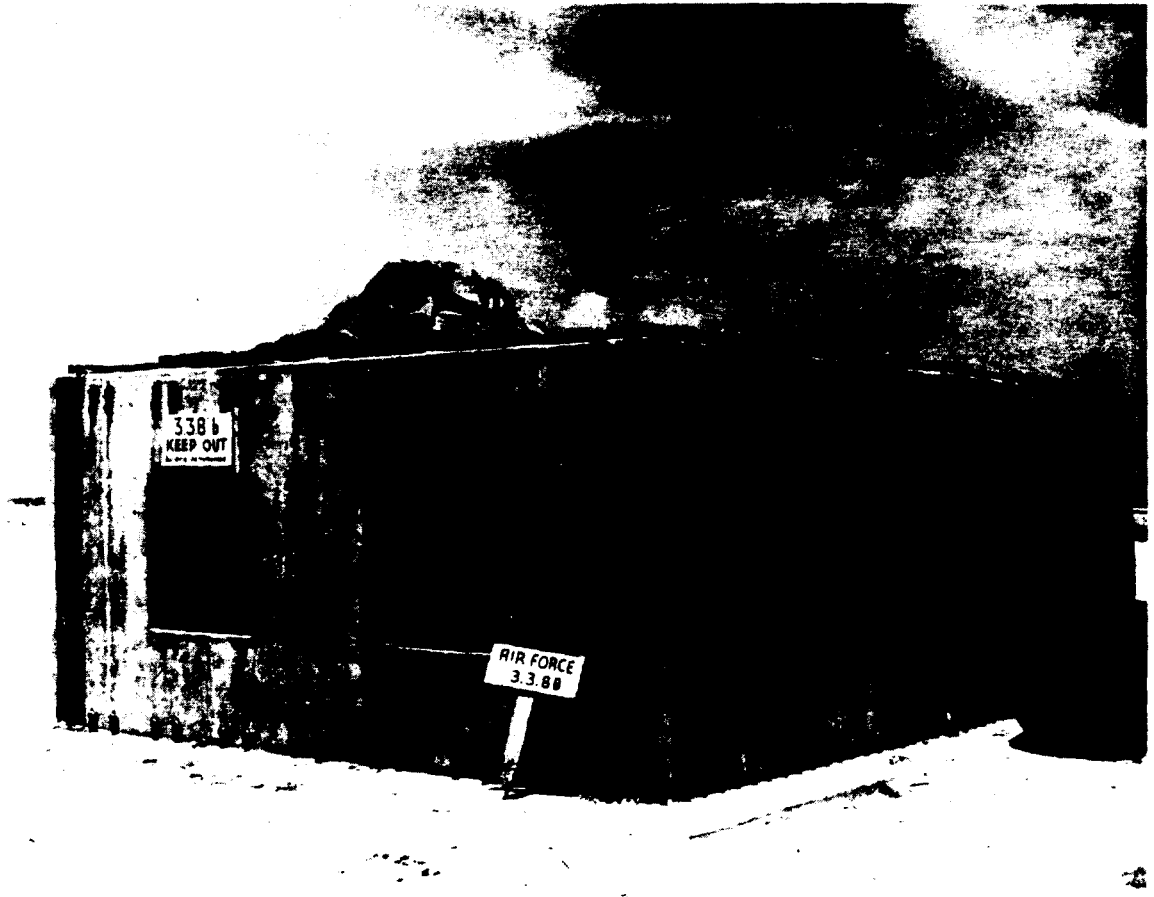
Air Force Station 3.3.8b, Precast Wall Sections.
