AN
INSPECTION REPORT
OF
WEATHER AND RAD-SAFE STATIONS

30 July Thru 3 August 1959

WEATHER STATION - PONAPE

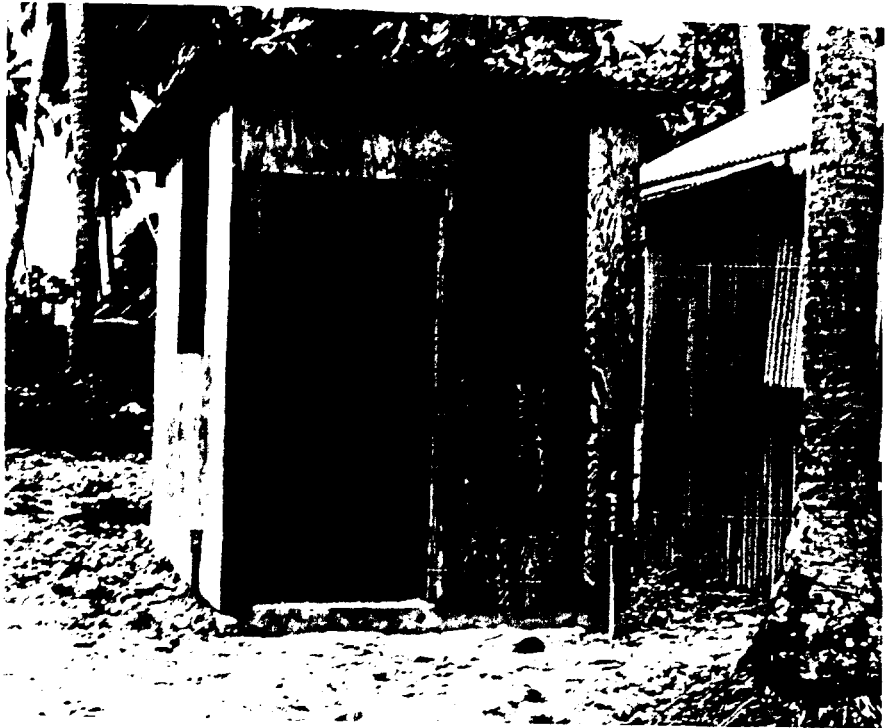
CLASSIFICATION	030	<input checked="" type="checkbox"/> INFORMATION
PHOTOGRAPHER	GCE	<input type="checkbox"/> PICTORIAL
		<input type="checkbox"/> PROGRESS _____ %
<u>13-35-12-3</u>	<u>7-30-59</u>	<u>Ujelang</u>
NEGATIVE NO.	DATE	SITE
Shower

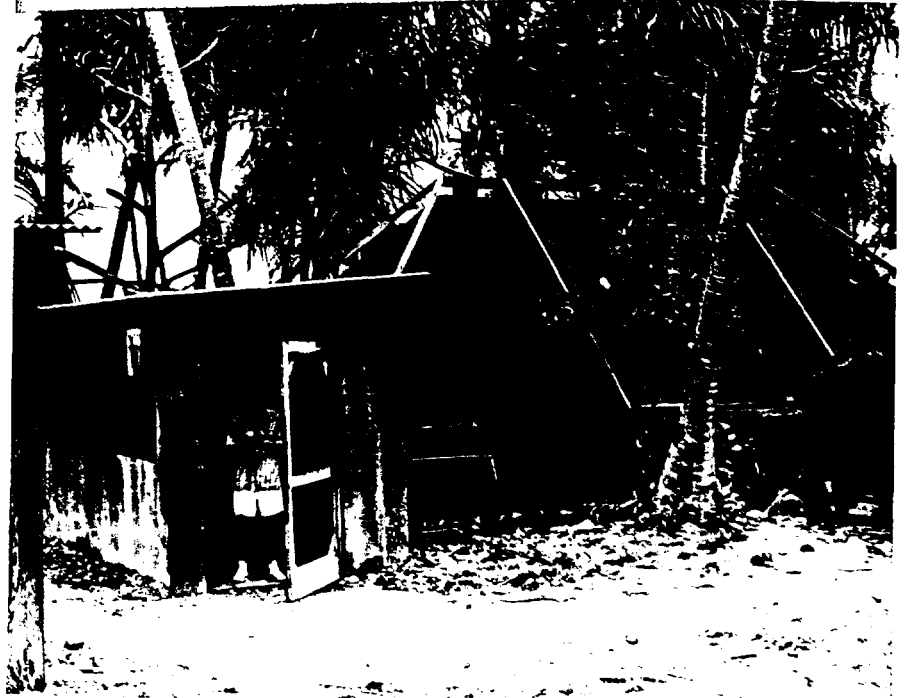
CLASSIFICATION	030	<input checked="" type="checkbox"/> INFORMATION
PHOTOGRAPHER	GCE	<input type="checkbox"/> PICTORIAL
		<input type="checkbox"/> PROGRESS _____ %
<u>13-35-12-4</u>	<u>7-30-59</u>	<u>Ujelang</u>
NEGATIVE NO.	DATE	SITE
WATER AND LAUNDRY BLDG

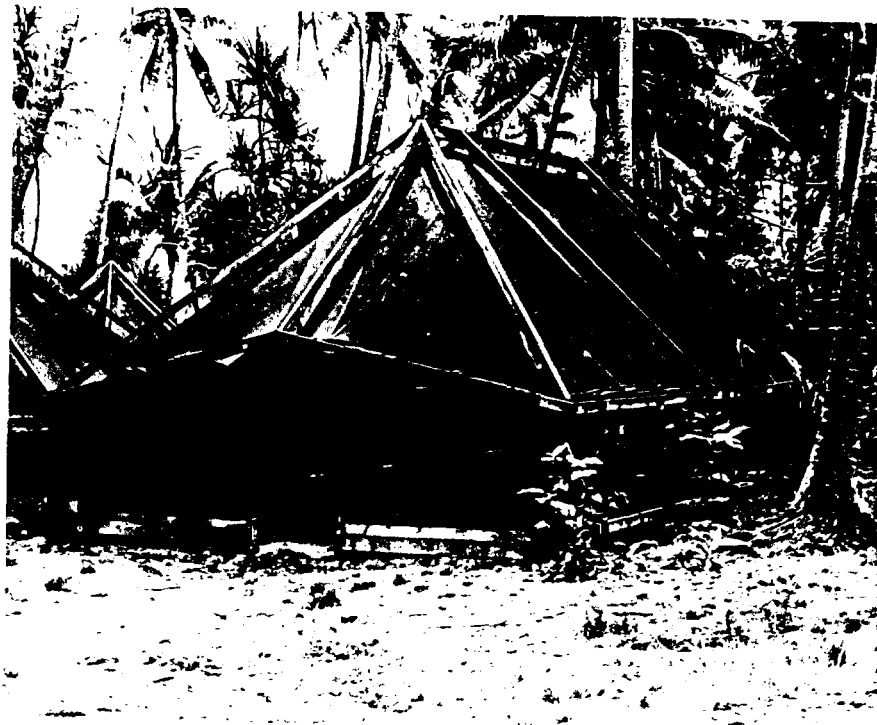
CLASSIFICATION	CUO	<input checked="" type="checkbox"/> INFORMATION
PHOTOGRAPHER	COE	<input type="checkbox"/> PICTORIAL
		<input type="checkbox"/> PROGRESS _____ %
<u>13-35-12-5</u>	<u>7-30-59</u>	<u>Ujalang</u>
NEGATIVE NO.	DATE	SITE
LIVING QUARTERS TENT

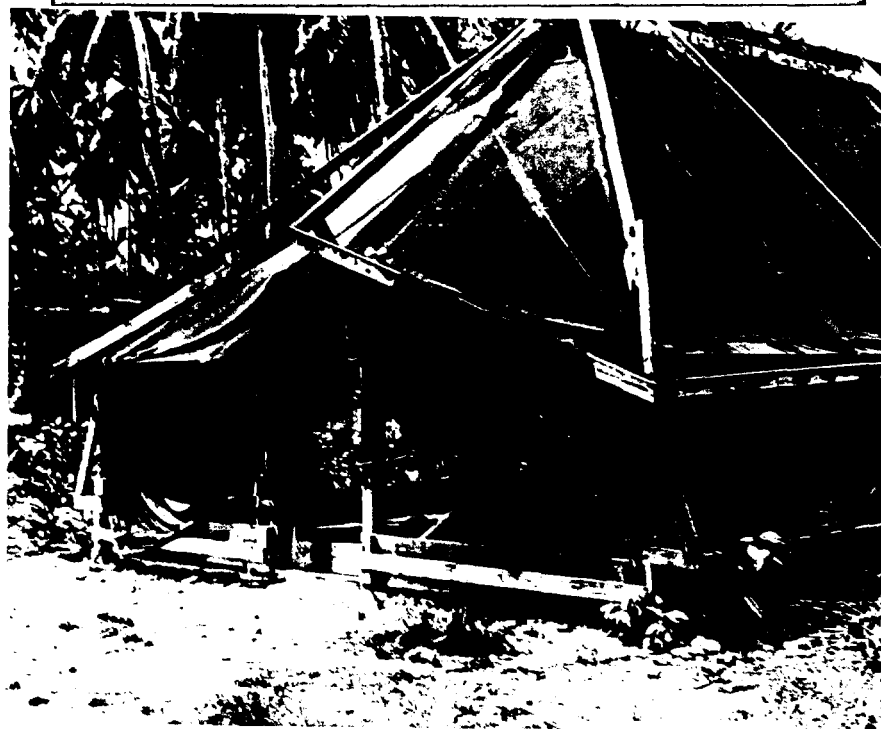
CLASSIFICATION	CUO	<input checked="" type="checkbox"/> INFORMATION
PHOTOGRAPHER	COE	<input type="checkbox"/> PICTORIAL
		<input type="checkbox"/> PROGRESS _____ %
<u>13-35-12-6</u>	<u>7-30-59</u>	<u>Ujalang</u>
NEGATIVE NO.	DATE	SITE
Living Quarters Tent

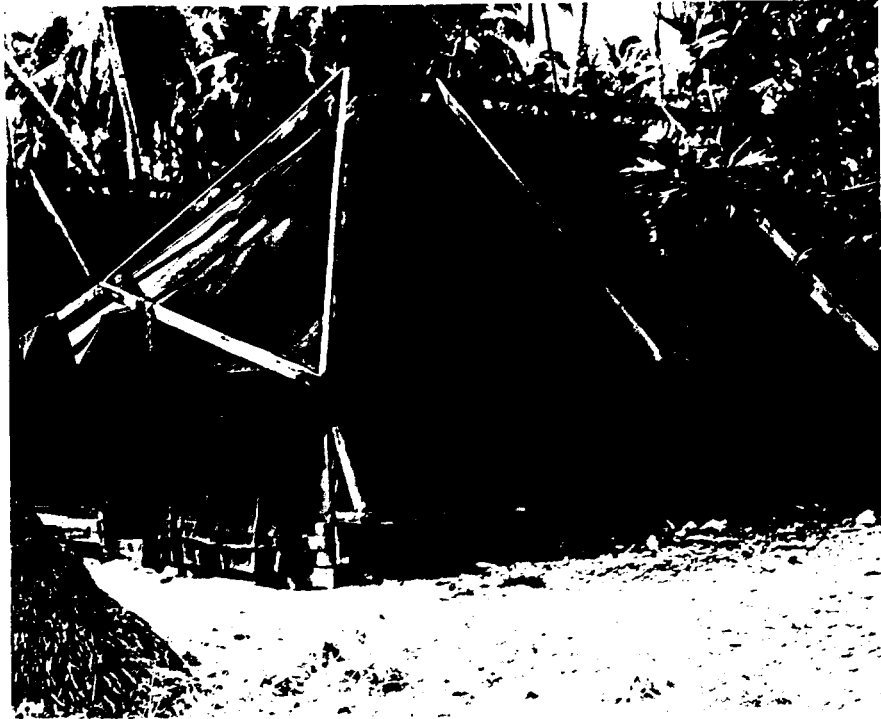
CLASSIFICATION	030	<input checked="" type="checkbox"/> INFORMATION
PHOTOGRAPHER	COB	<input type="checkbox"/> PICTORIAL
		<input type="checkbox"/> PROGRESS _____ %
<u>13-35-12-7</u>	<u>7-30-59</u>	<u>Ujelang</u>
NEGATIVE NO.	DATE	SITE
DATROOM

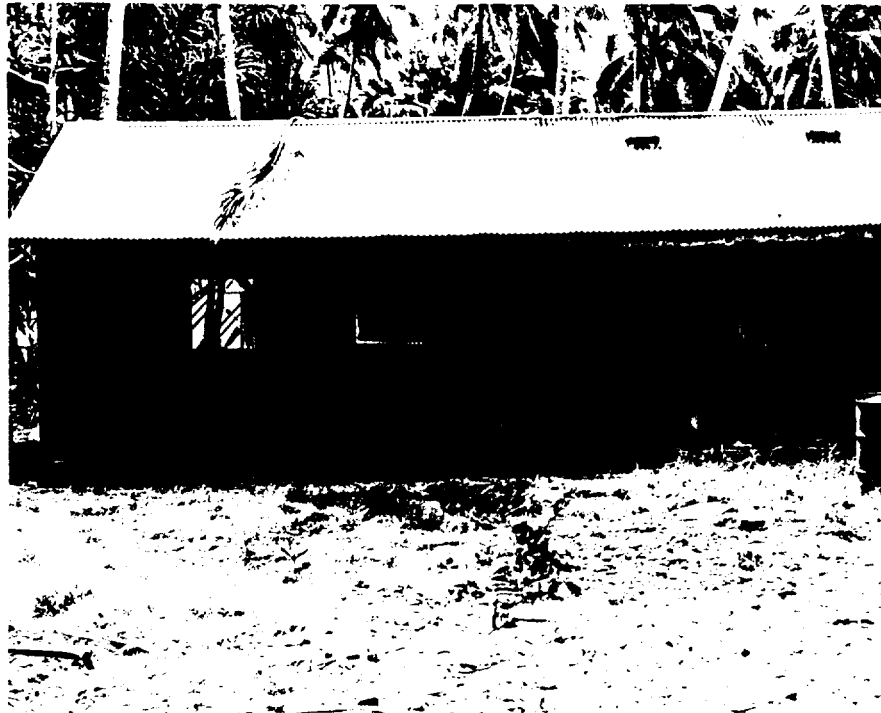
CLASSIFICATION	030	<input checked="" type="checkbox"/> INFORMATION
PHOTOGRAPHER	COE	<input type="checkbox"/> PICTORIAL
		<input type="checkbox"/> PROGRESS _____ %
<u>13-35-12-9</u>	<u>7-30-59</u>	<u>Ujelang</u>
NEGATIVE NO.	DATE	SITE
POWER & DISTILLATION

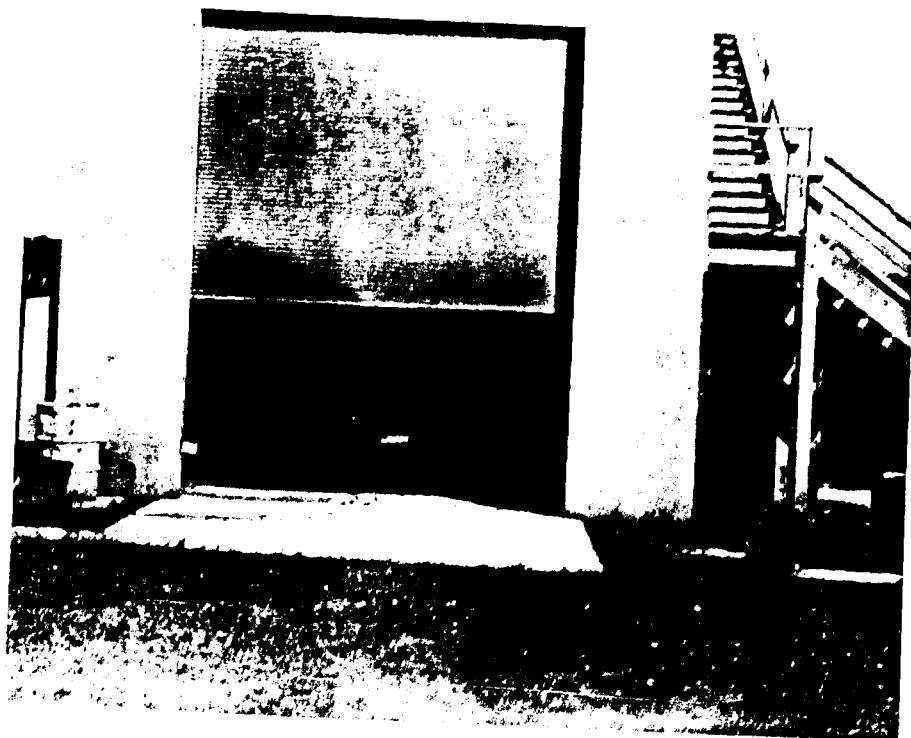
1. The weather station building, which is being operated by the U.S. Weather Bureau, appears to be in very good condition structurally. A small amount of dry rot occurs at the base of the stair posts and Mr. Hirada intends to have the posts incased in concrete approximately 12" above the footings. During windy rainstorms, a small portion of the roof develops slight leaks. This he proposes to repair with mastic and metal flashing. Mr. Hirata further proposes to build a small shelter to house an emergency generator. This will keep the station operable during power failures at the main plant.

CLASSIFICATION	000	<input checked="" type="checkbox"/> INFORMATION
PHOTOGRAPHER	COE	<input type="checkbox"/> PICTORIAL
		<input type="checkbox"/> PROGRESS _____ %
<u>13-35-12-13</u>	<u>7-30-99</u>	<u>Ponape</u>
NEGATIVE NO.	DATE	SITE
VIEW OF END OF STATION

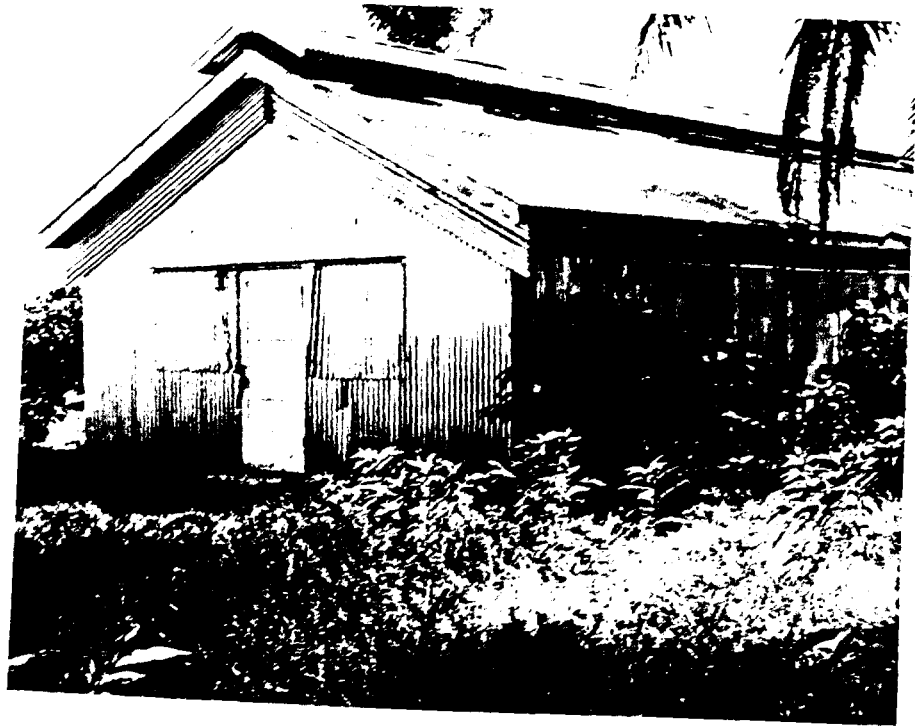
CLASSIFICATION **000** INFORMATION
 PHOTOGRAPHER **COE** PICTORIAL
 PROGRESS _____ %
13-35-12-16 **8-1-59** **Kapingarangi**
 NEGATIVE NO. DATE SITE
VIEW OF SE END OF DAYROOM

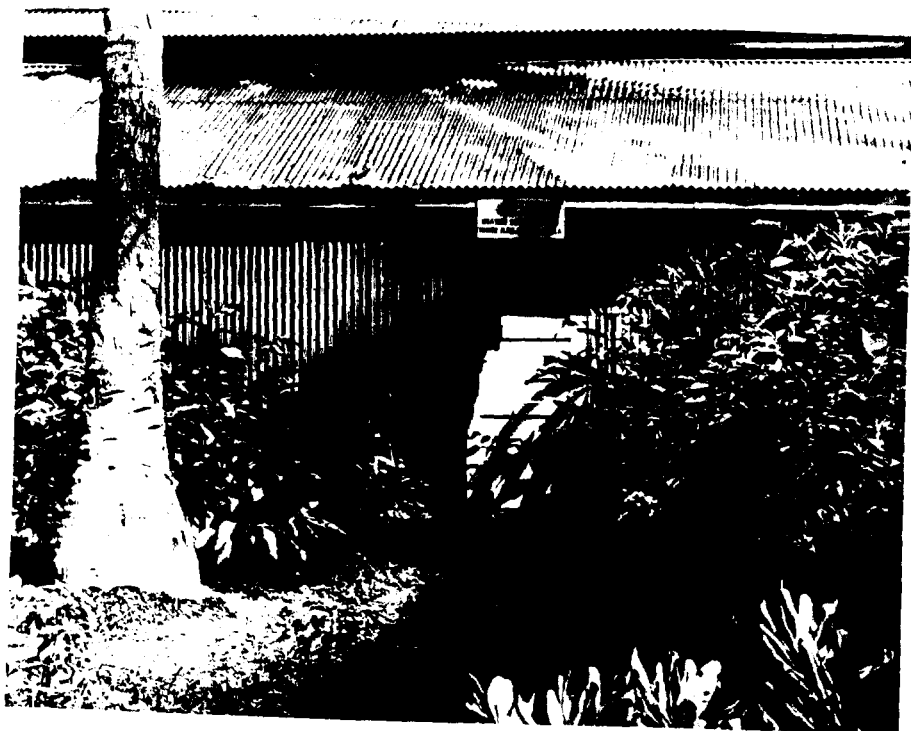
CLASSIFICATION **000** INFORMATION
 PHOTOGRAPHER **COE** PICTORIAL
 PROGRESS _____ %
13-35-12-17 **8-1-59** **Kapingarangi**
 NEGATIVE NO. DATE SITE
VIEW OF E. SIDE OF DAYROOM

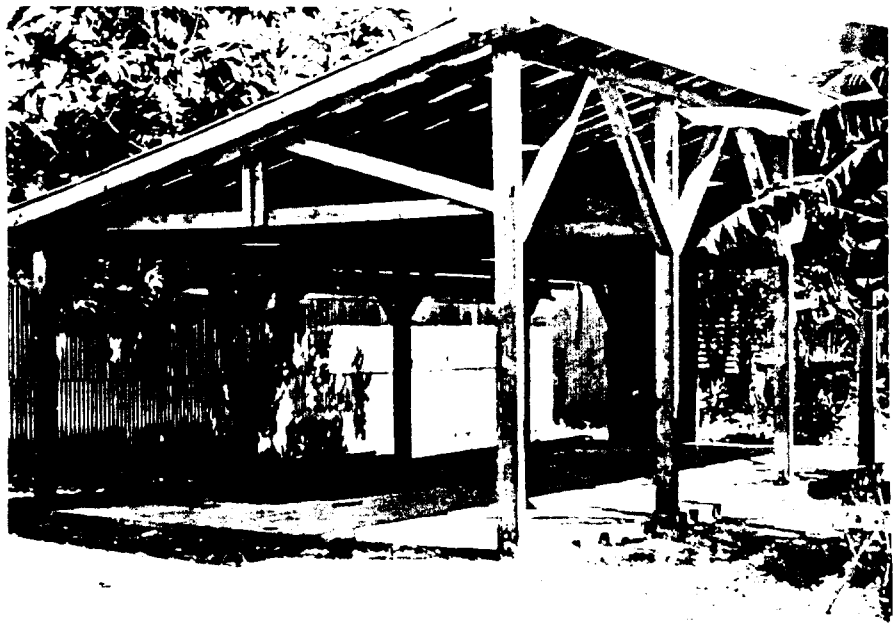
CLASSIFICATION	000	<input checked="" type="checkbox"/> INFORMATION
PHOTOGRAPHER	COE	<input type="checkbox"/> PICTORIAL
		<input type="checkbox"/> PROGRESS _____ %
<u>13-35-13-1</u>	<u>8-2-59</u>	<u>Kusafu</u>
NEGATIVE NO.	DATE	SITE
	KEEPER BLDG.	SITE "A"

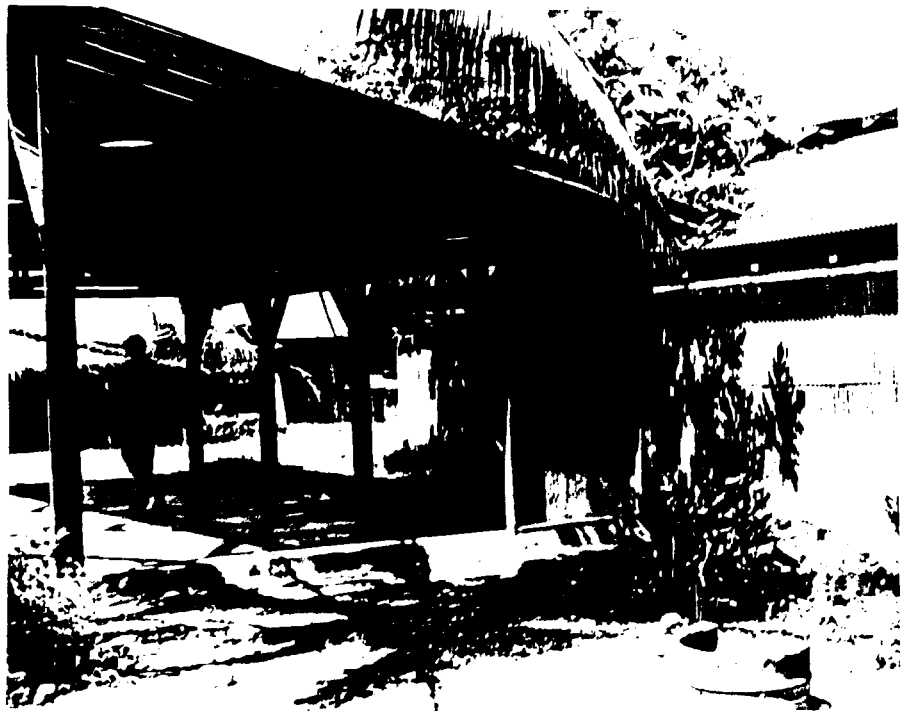
CLASSIFICATION	000	<input checked="" type="checkbox"/> INFORMATION
PHOTOGRAPHER	COE	<input type="checkbox"/> PICTORIAL
		<input type="checkbox"/> PROGRESS _____ %
<u>13-35-13-5</u>	<u>8-2-59</u>	<u>KUSAIB</u>
NEGATIVE NO.	DATE	SITE
VIEW OF ROBERTS BLDG		SITE "A"

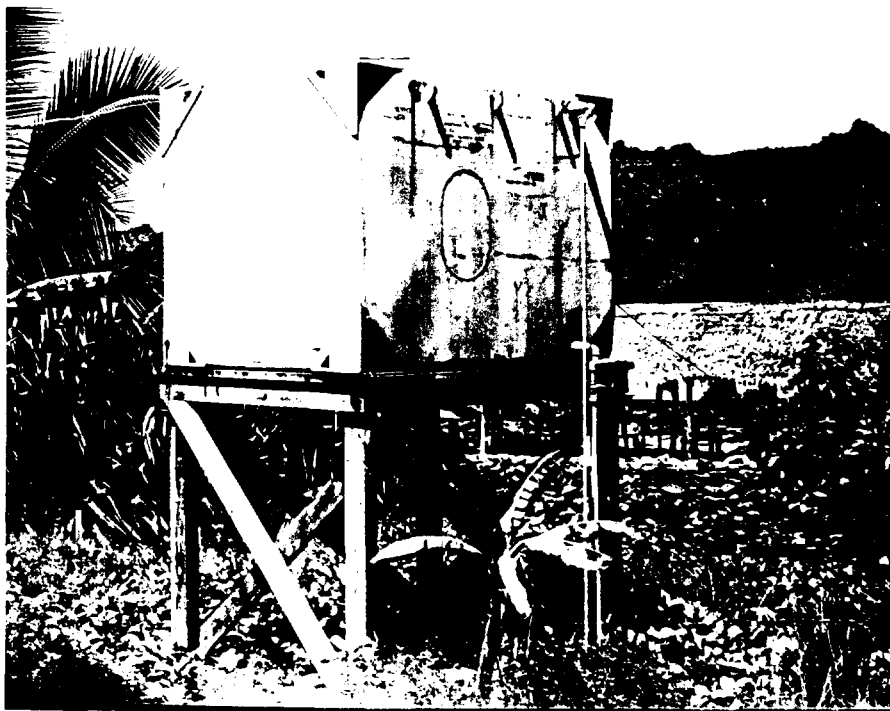
1. SUPPLY & OPERATIONS - In good condition.
2. GENERATOR SHED - In good condition.
3. RAWINSONDE TOWER - In good condition. However the vertical steel poles and steel angles are beginning to show signs of rust.
4. PIT LATRINE - Apparently good condition, but should be replaced.
5. FUEL TANK BASE - In good condition.
6. REEFER SHED - In good condition.

CLASSIFICATION	OUO	<input checked="" type="checkbox"/> INFORMATION
PHOTOGRAPHER	COB	<input type="checkbox"/> PICTORIAL
		<input type="checkbox"/> PROGRESS _____ %
<u>13-35-13-7</u>	<u>8-2-59</u>	<u>Rusaie</u>
NEGATIVE NO.	DATE	SITE
FUEL TANK & BASE		SITE "A"

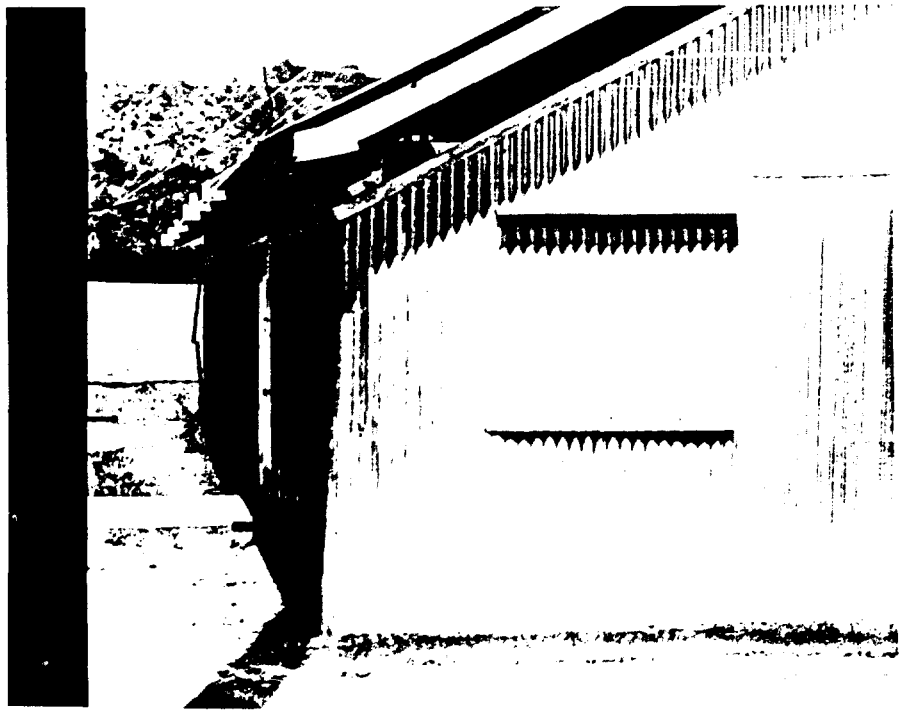
CLASSIFICATION	000	<input checked="" type="checkbox"/> INFORMATION
PHOTOGRAPHER	COE	<input type="checkbox"/> PICTORIAL
		<input type="checkbox"/> PROGRESS..... %
<u>13-35-13-13</u>	<u>8-2-59</u>	<u>Kusale</u>
NEGATIVE NO.	DATE	SITE
SW END BARRACKS BLDG. # 5		SITE "B"

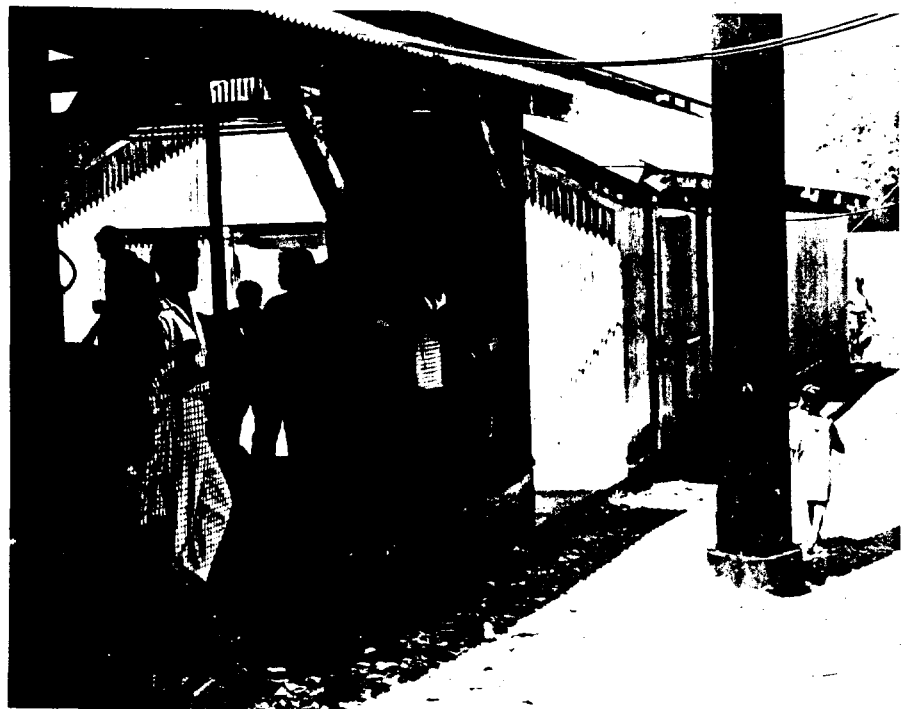
CLASSIFICATION	000	<input checked="" type="checkbox"/> INFORMATION
PHOTOGRAPHER	COE	<input type="checkbox"/> PICTORIAL
		<input type="checkbox"/> PROGRESS..... %
<u>13-35-13-14</u>	<u>8-2-59</u>	<u>Kusale</u>
NEGATIVE NO.	DATE	SITE
GREEN BANK & WATKINS FOLD		SITE "B"

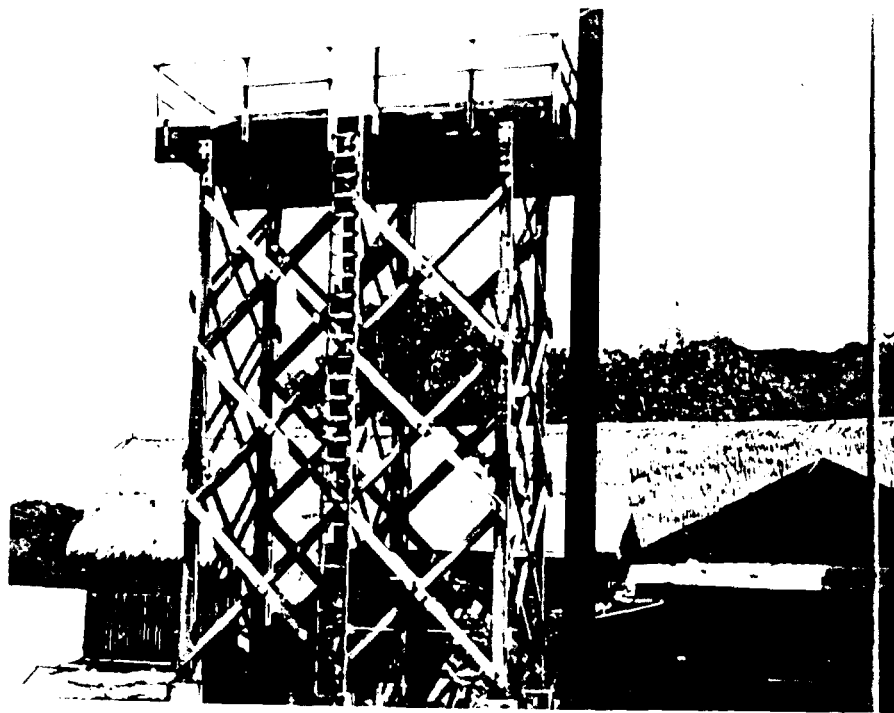
CLASSIFICATION	CUO	<input checked="" type="checkbox"/> INFORMATION
PHOTOGRAPHER	COE	<input type="checkbox"/> PICTORIAL
		<input type="checkbox"/> PROGRESS _____ %
<u>13-35-13-17</u>	<u>8-2-59</u>	<u>Kumalo</u>
NEGATIVE NO.	DATE	SITE
WATER TOWER		SITE "B"

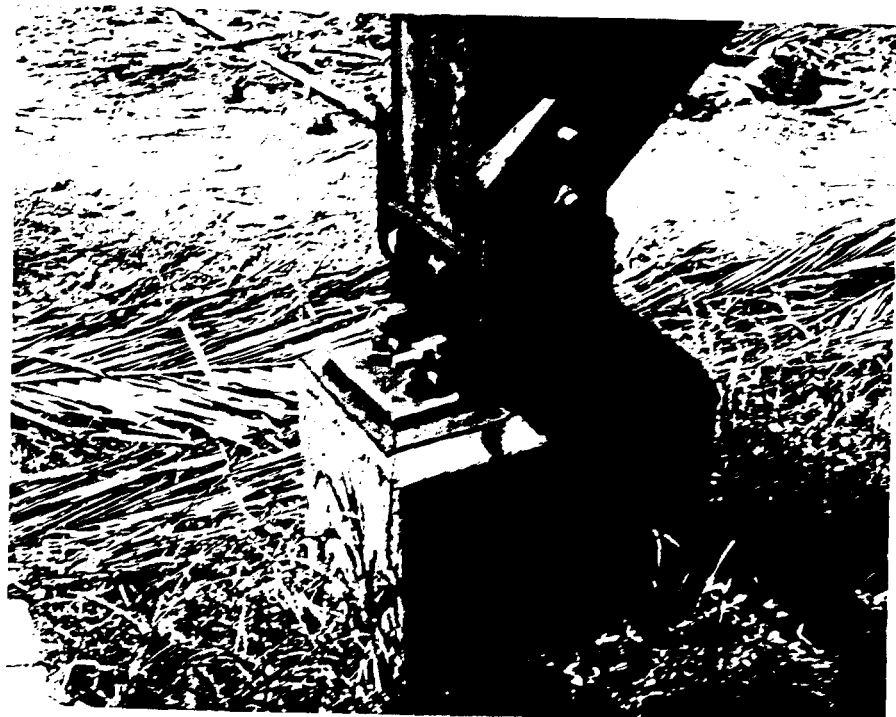
CLASSIFICATION	CUO	<input checked="" type="checkbox"/> INFORMATION
PHOTOGRAPHER	COE	<input type="checkbox"/> PICTORIAL
		<input type="checkbox"/> PROGRESS _____ %
<u>13-35-13-18</u>	<u>8-2-59</u>	<u>Kumalo</u>
NEGATIVE NO.	DATE	SITE
SECTION OF WATER TOWER BASES SITE "B"

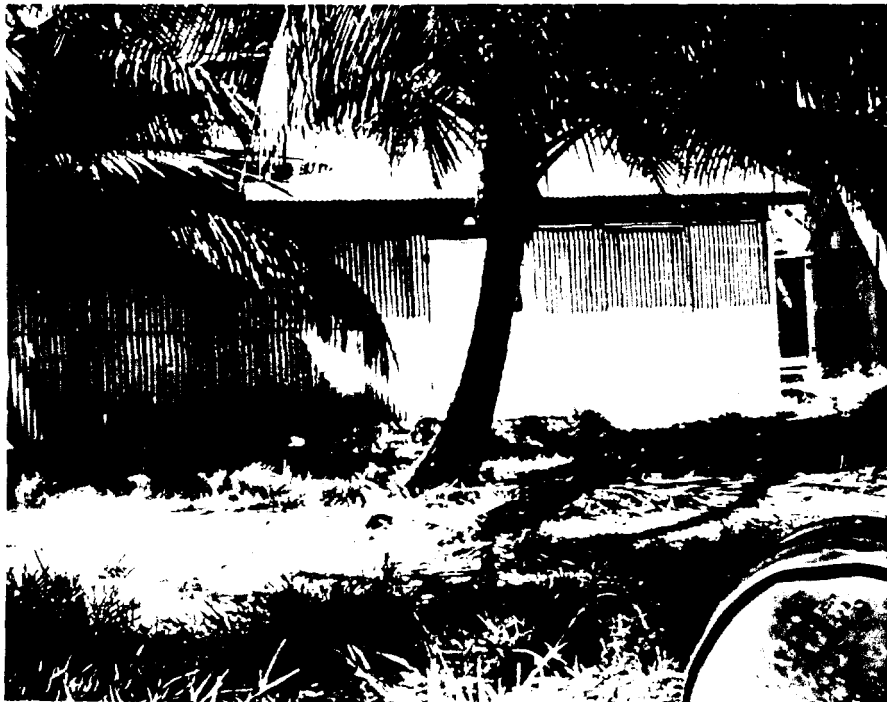
CLASSIFICATION	CUO	<input checked="" type="checkbox"/> INFORMATION
PHOTOGRAPHER	COE	<input type="checkbox"/> PICTORIAL
		<input type="checkbox"/> PROGRESS _____ %
<u>13-35-14-1</u>	<u>8-3-59</u>	<u>Utirik</u>
NEGATIVE NO.	DATE	SITE
BARRACKS BLDG. / 1

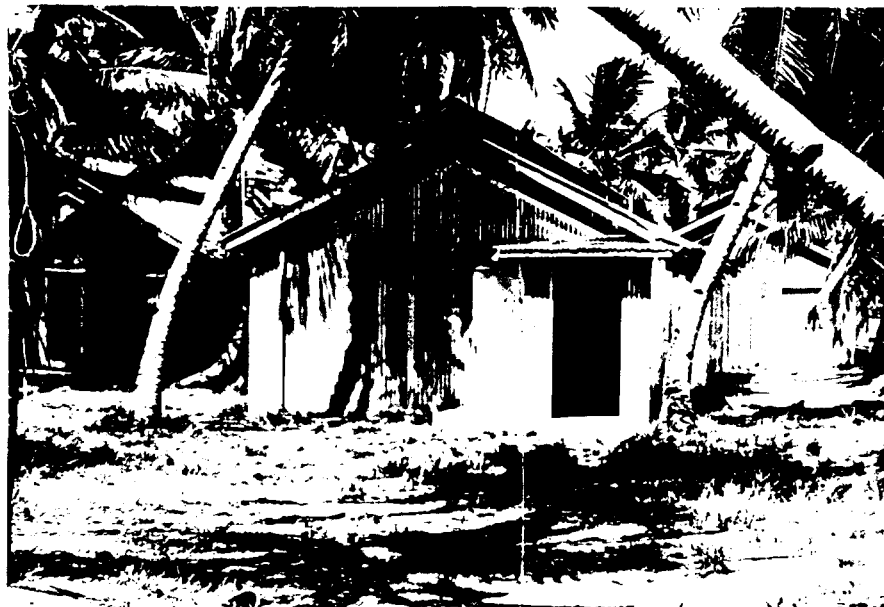
CLASSIFICATION	OUO	<input checked="" type="checkbox"/> INFORMATION
PHOTOGRAPHER	CCB	<input type="checkbox"/> PICTORIAL
		<input type="checkbox"/> PROGRESS _____ %
13-35-14-3	8-3-59	Utirik
NEGATIVE NO.	DATE	SITE
Dayroom BLDG # 3

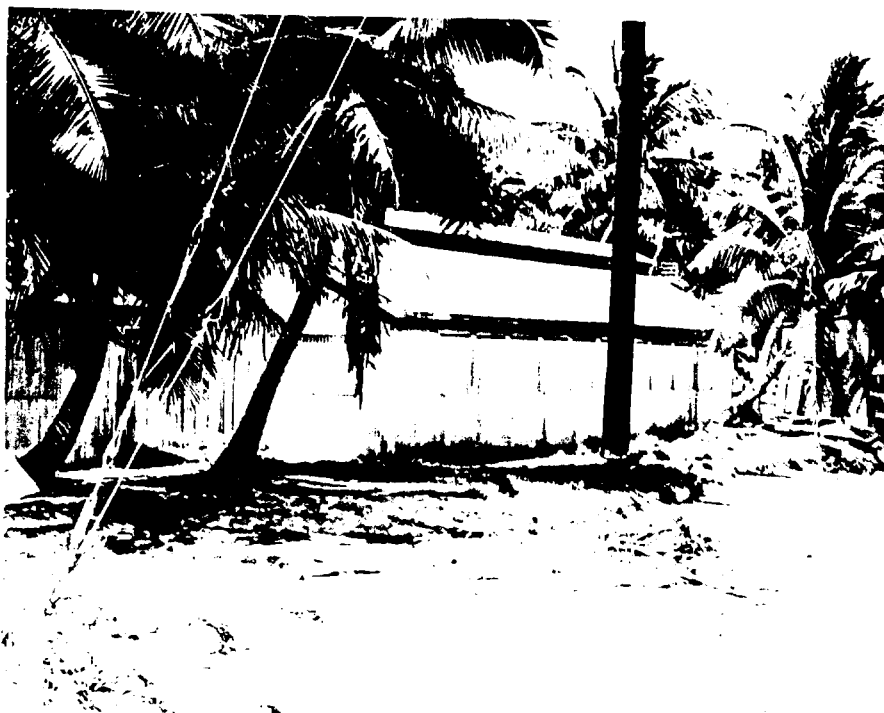
CLASSIFICATION	OUO	<input checked="" type="checkbox"/> INFORMATION
PHOTOGRAPHER	CCB	<input type="checkbox"/> PICTORIAL
		<input type="checkbox"/> PROGRESS _____ %
13-35-14-4	8-3-59	Utirik
NEGATIVE NO.	DATE	SITE
OPERATIONS & SUPPLY BLDG. # 5

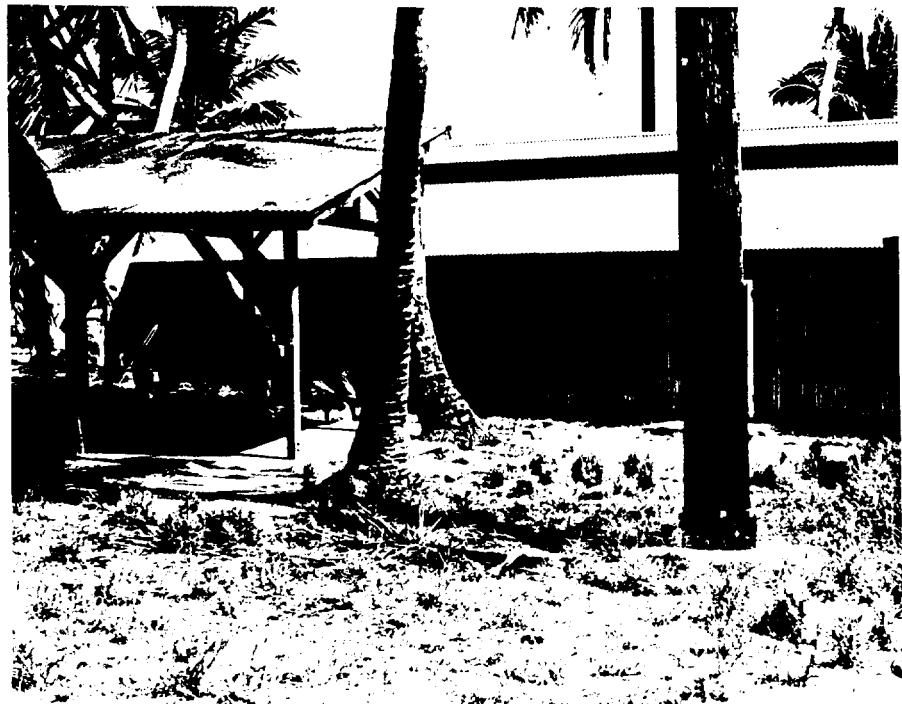
CLASSIFICATION	OOO	<input checked="" type="checkbox"/> INFORMATION
PHOTOGRAPHER	COB	<input type="checkbox"/> PICTORIAL
		<input type="checkbox"/> PROGRESS.....%
<u>13-35-14-8</u>	<u>8-3-59</u>	<u>Utirik</u>
NEGATIVE NO.	DATE	SITE
KEEPER BANK BLDG # 8

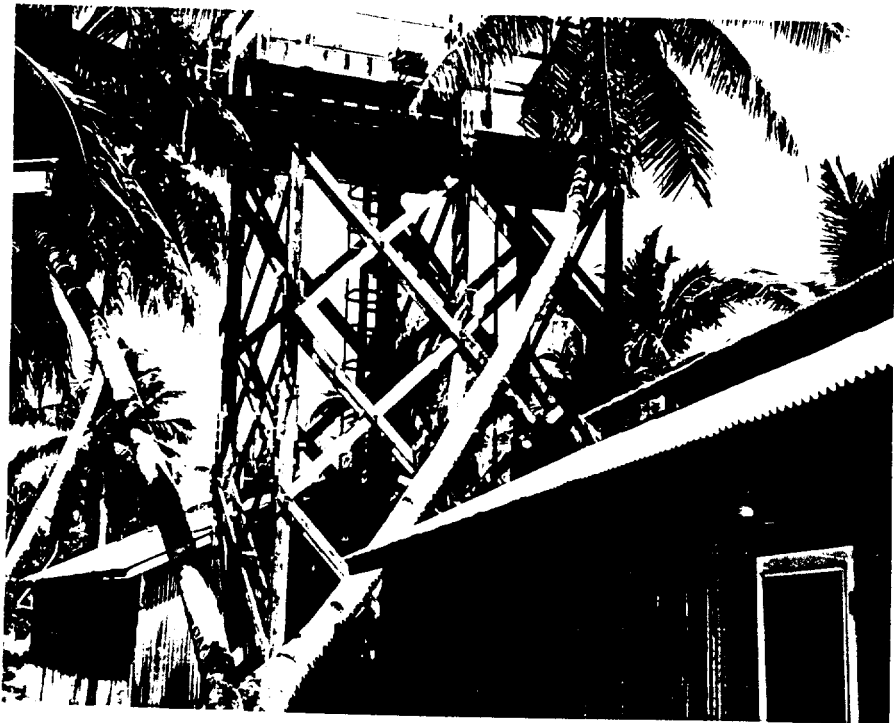
CLASSIFICATION	000	<input checked="" type="checkbox"/> INFORMATION
PHOTOGRAPHER	CCS	<input type="checkbox"/> PICTORIAL
		<input type="checkbox"/> PROGRESS _____ %
<u>13-35-14-9</u>	<u>8-3-59</u>	<u>Utirik</u>
NEGATIVE NO.	DATE	SITE
WATER TOWER BLDG. #9

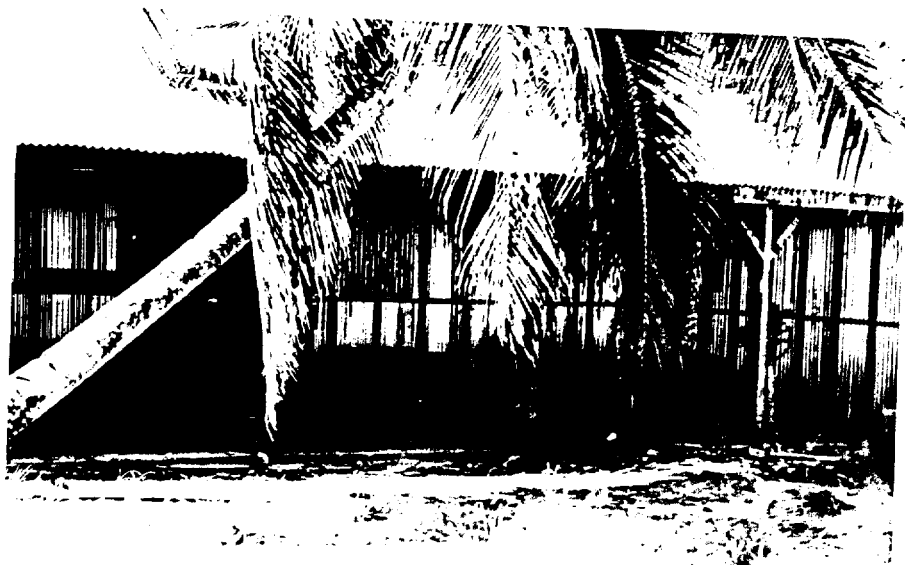
CLASSIFICATION	000	<input checked="" type="checkbox"/> INFORMATION
PHOTOGRAPHER	CCS	<input type="checkbox"/> PICTORIAL
		<input type="checkbox"/> PROGRESS _____ %
<u>13-35-14-10</u>	<u>8-3-59</u>	<u>Utirik</u>
NEGATIVE NO.	DATE	SITE
POWER & DISTILLATION BLDG. # 10

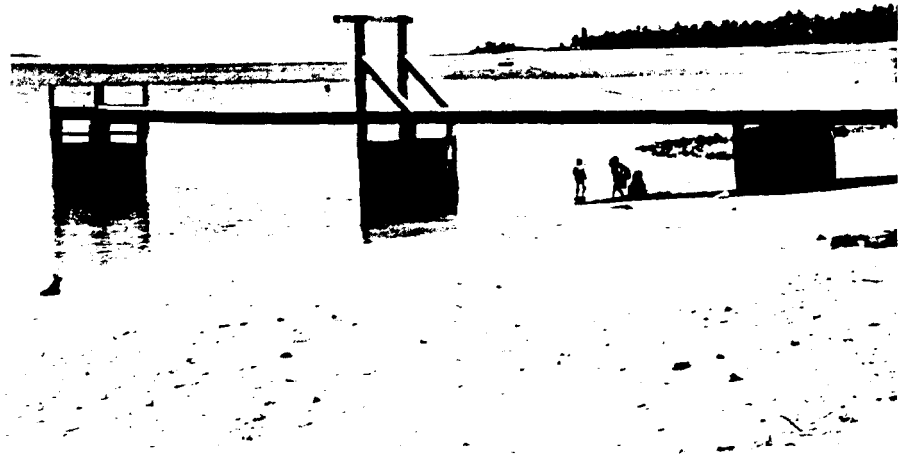
CLASSIFICATION	CUO	<input checked="" type="checkbox"/> INFORMATION
PHOTOGRAPHER	COE	<input type="checkbox"/> PICTORIAL
		<input type="checkbox"/> PROGRESS _____ %
<u>13-35-16-11</u>	<u>8-3-59</u>	<u>Utirik</u>
NEGATIVE NO.	DATE	SITE
P12R

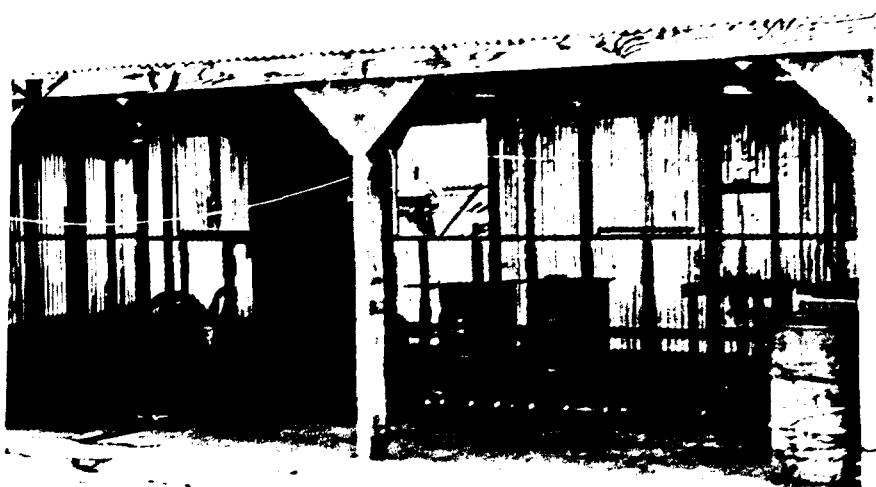
CLASSIFICATION	CUO	<input checked="" type="checkbox"/> INFORMATION
PHOTOGRAPHER	COE	<input type="checkbox"/> PICTORIAL
		<input type="checkbox"/> PROGRESS _____ %
13-35-15-15	8-3-59	Yoko
NEGATIVE NO.	DATE	SITE
POWER & DISTILLATION BLDG.

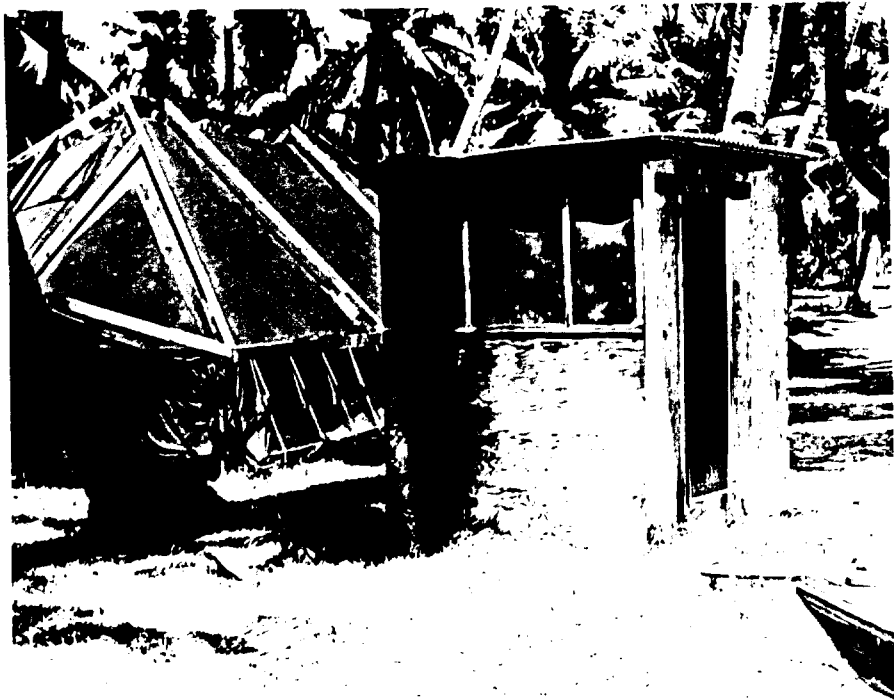
CLASSIFICATION	OCB	<input checked="" type="checkbox"/> INFORMATION
PHOTOGRAPHER	COE	<input type="checkbox"/> PICTORIAL
		<input type="checkbox"/> PROGRESS _____ %
13-35-14-16	8-3-59	Mothe
NEGATIVE NO.	DATE	SITE
PIT LATRINE

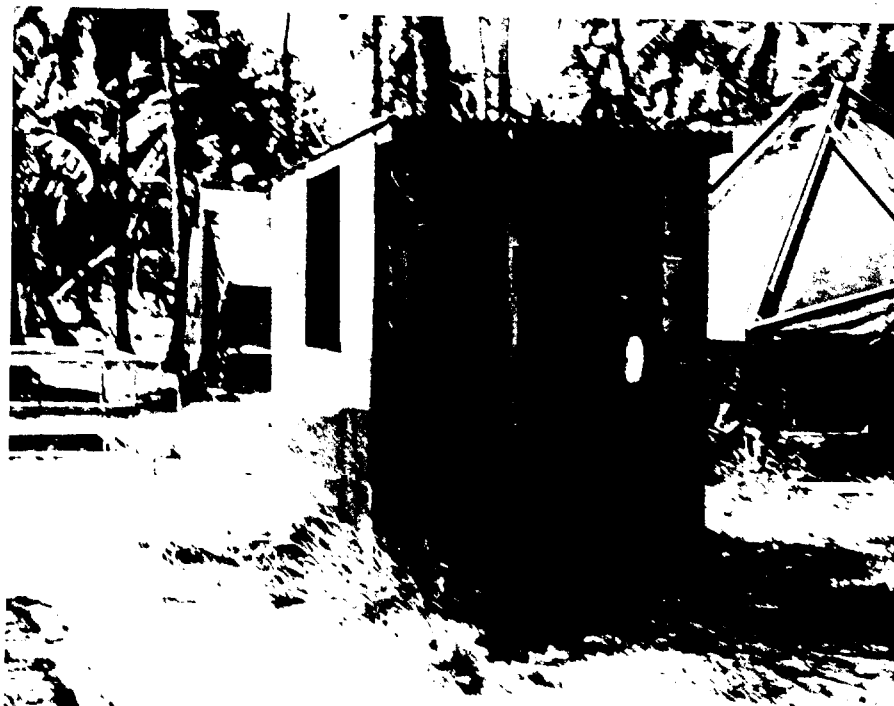
CLASSIFICATION	OCB	<input checked="" type="checkbox"/> INFORMATION
PHOTOGRAPHER	COE	<input type="checkbox"/> PICTORIAL
		<input type="checkbox"/> PROGRESS _____ %
13-35-14-17	8-3-59	Mothe
NEGATIVE NO.	DATE	SITE
FIELD SHOWER

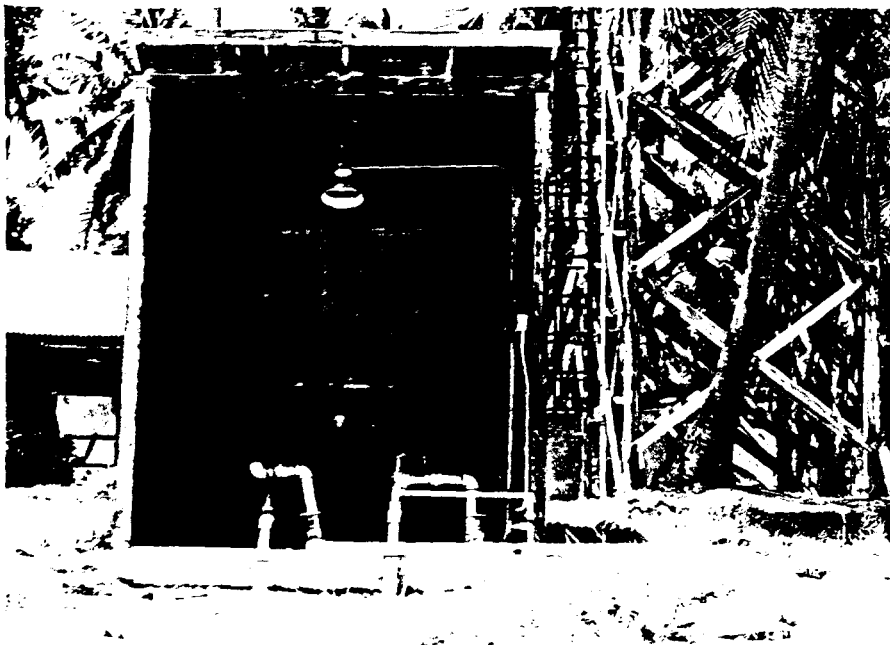
CLASSIFICATION	000	<input checked="" type="checkbox"/> INFORMATION
PHOTOGRAPHER	CCB	<input type="checkbox"/> PICTORIAL
		<input type="checkbox"/> PROGRESS
13-33-14-18	8-7-57	Water
NEGATIVE NO.	DATE	SITE
PUMP HOUSE

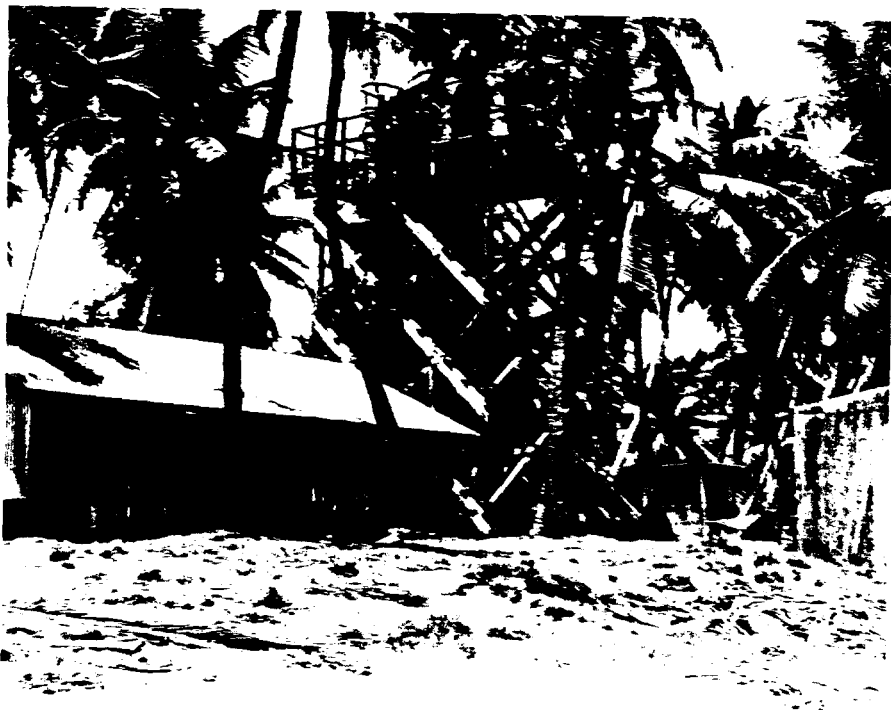
CLASSIFICATION	000	<input checked="" type="checkbox"/> INFORMATION
PHOTOGRAPHER	CCB	<input type="checkbox"/> PICTORIAL
		<input type="checkbox"/> PROGRESS
13-35-14-19	8-3-57	Water
NEGATIVE NO.	DATE	SITE
WATER TOWER
