COMPLETION REPORT OPERATION CASTLE

U. S. ATOMIC ENERGY COMMISSION — CONTRACT AT-(29-2)-20
PACIFIC PROVING GROUND • 1953 - 1954

HOLMES & NARVER, INC.
LOS ANGELES, CALIFORNIA

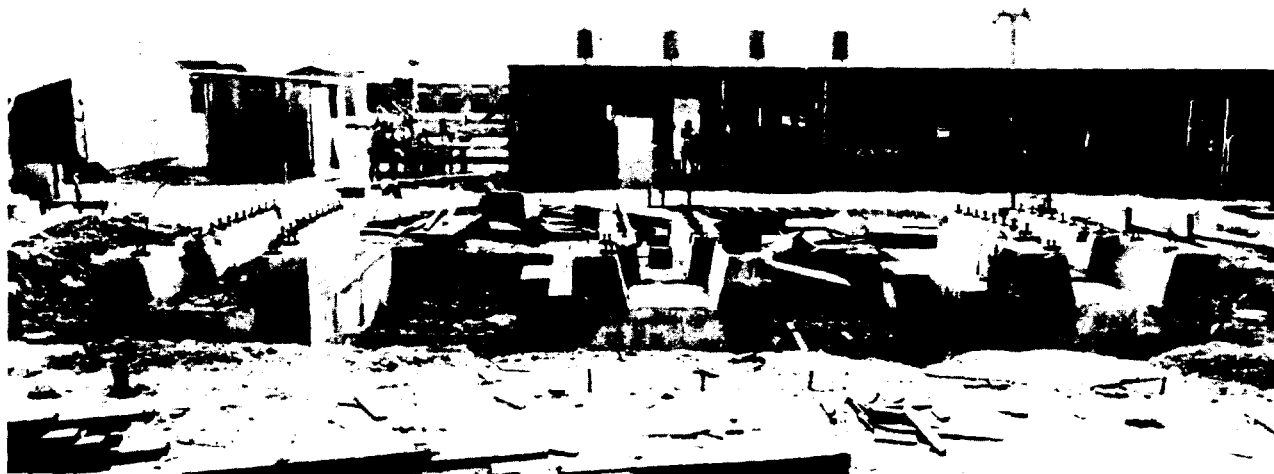
Figure 2-201. Scientific Power Plants - Typical Foundations

GENERAL. The scientific power requirements known in early 1953 were examined and it was determined that one central electric power generation plant for a closely related group of Scientific Stations, to be used for one test, would be the most feasible. A single plant with a few large units (in lieu of single independent plants) was more economical to build and operate, more reliable in voltage and frequency control, more stable under varying load conditions within the limits of an economical distribution system, and where the function of a unitized system could be related to a single test. On 1 May 1953 it was recommended that central Power Plants for power generation be established at sites Charlie, Dog, Nan, Tare and Ursula. On 5 June 1953 these recommendations were approved. At site Ursula, IVY Station U-108 was reactivated for this purpose. At sites Charlie, Dog and Tare, expendable construction was used. At site Nan, Building NA-500 was a 38' - 0" x 49' - 0" x 14' - 0" high reinforced concrete structure with earth fill on one end and two sides to the finished grade. The roof had a two-foot thick earth fill over it and the exposed end wall of the building had a 15' - 0" long by 19' - 6" high maximum retaining wall

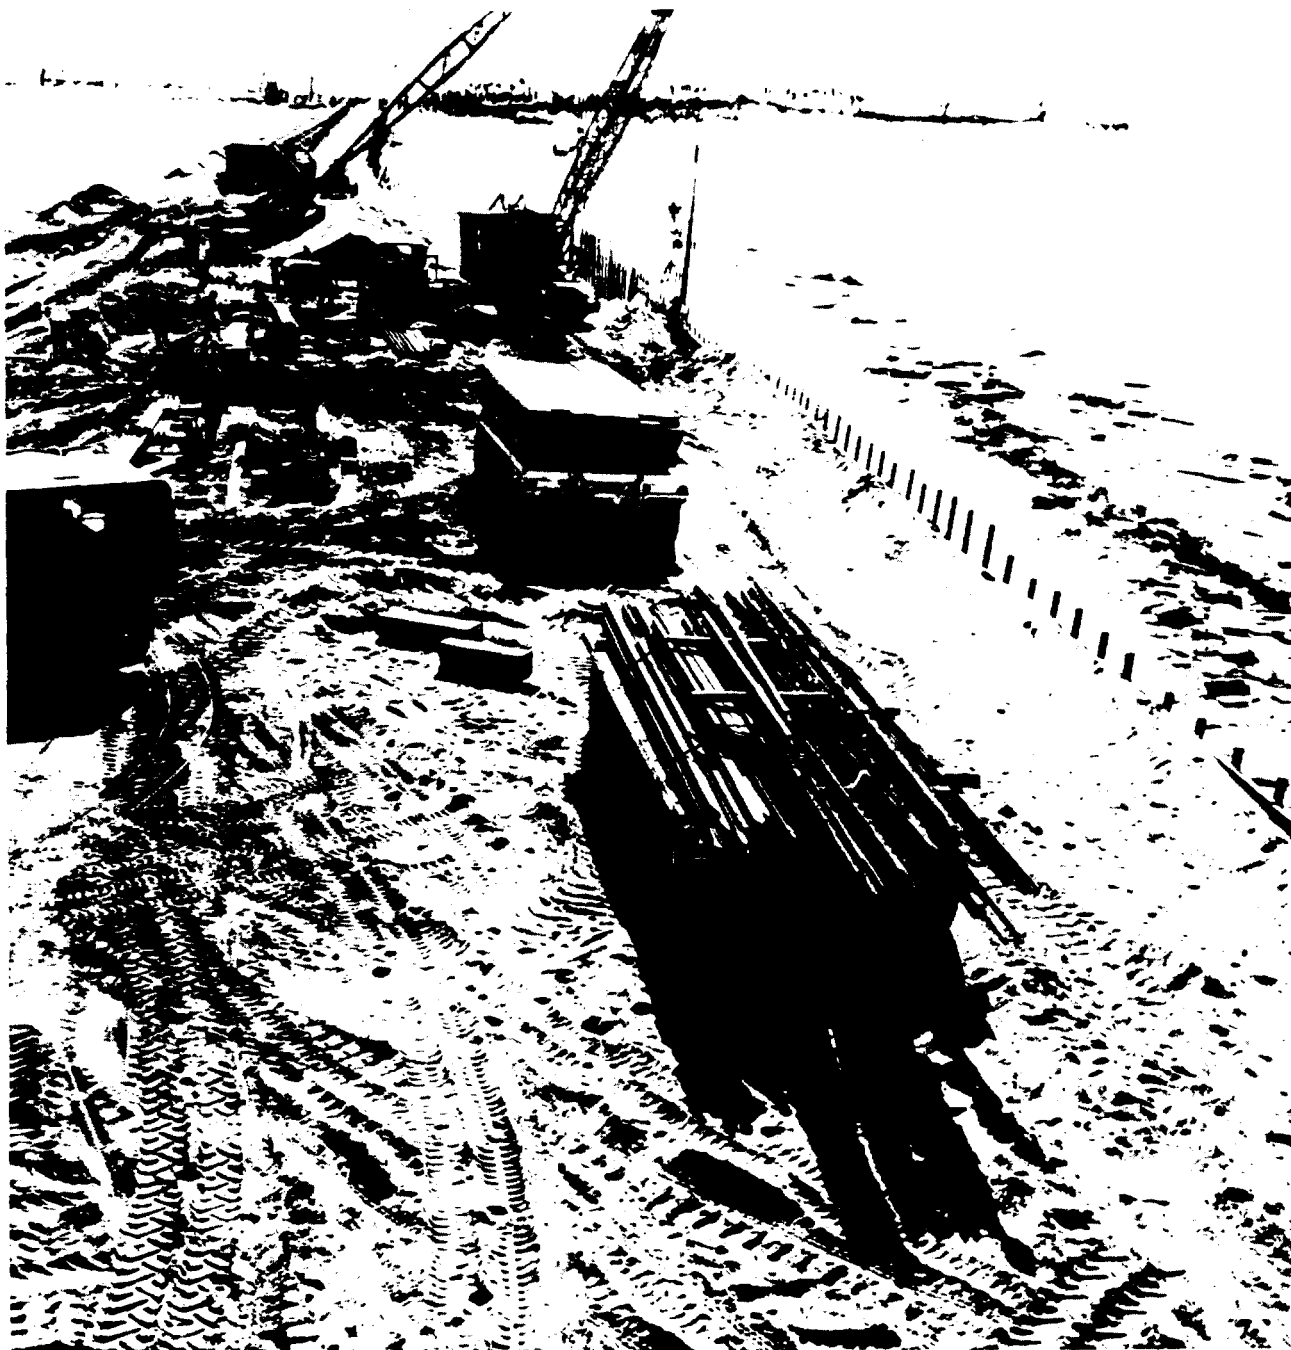
Figure 2-210. Charlie Causeway - Construction of Bulkhead

CONSTRUCTION - CHARLIE CAUSEWAY. This causeway was 87 feet wide at an elevation of plus 9.0, and was bulkheaded on the lagoon

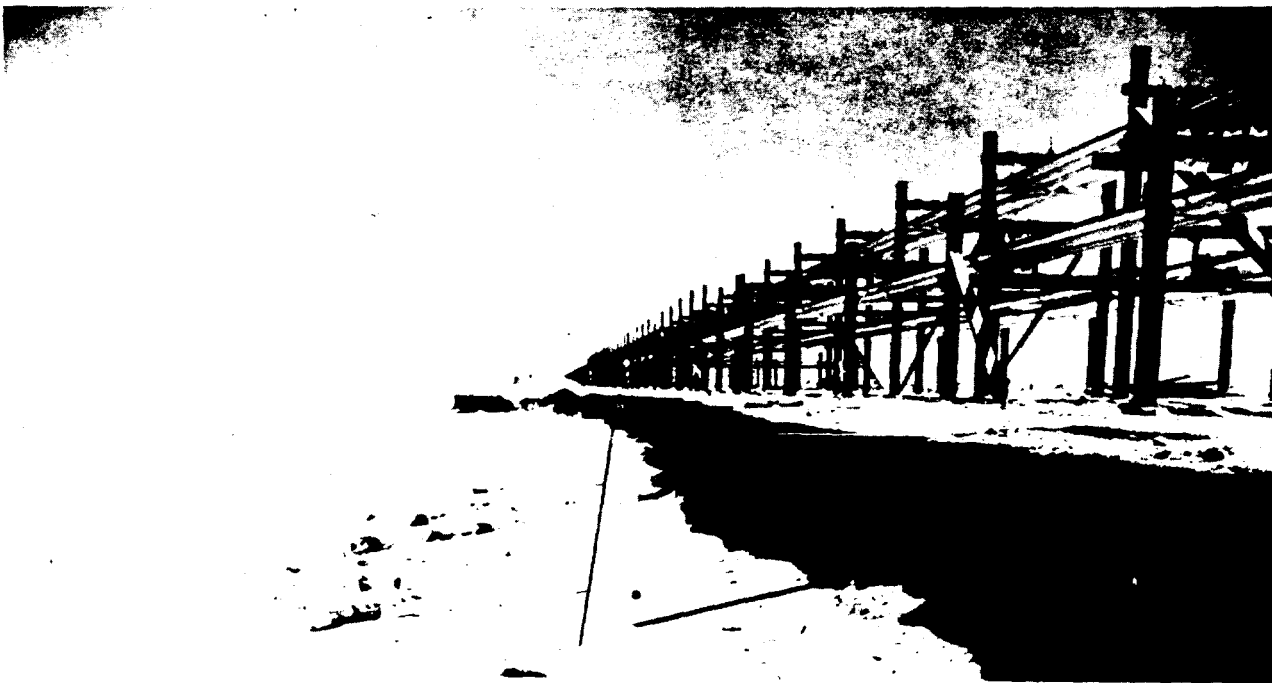
Figure 2-213. Charlie Causeway - Erosion from Wave Action

Figure 2-213 shows a typical example of erosion due to wave action on the ocean side. This photograph was taken on 4 December 1953. On the lagoon side the bulkheads experienced some damage due to tidal action. Figure 2-214 is a typical example in this respect.
